## Annual Inspection

Flitcham cum Appleton Parish Council

Flitcham cum Appleton

Abbey Road, Nr King's Lynn, Norfolk, PE31 6BT

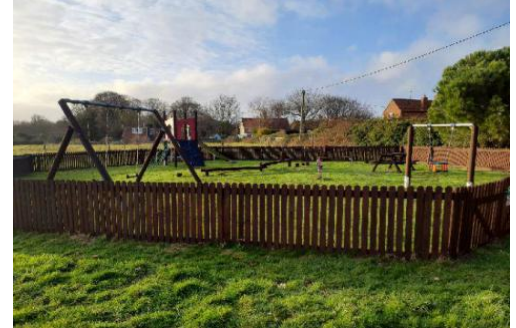
**Item:** Site General  
**Manufacturer:** Owner/Operator  
**Surface Type:** N/A  
**Item Quantity:** 1  
**Equipment Compliance:** N/A  
**Surface Area Compliance:** N/A

There are a number of molehills within the area and these may present unforeseen hazards for users - Remove moles by appropriate means, reinstate surfaces to level and maintain the area

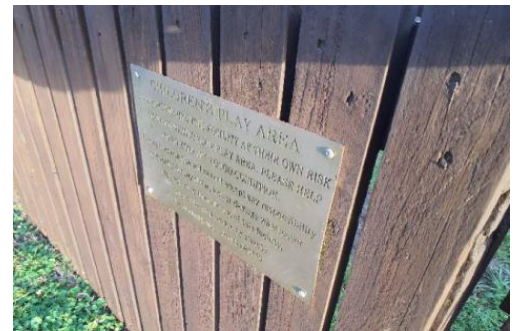
**Item:** Sign  
**Manufacturer:** Not Identified  
**Surface Type:** N/A  
**Item Quantity:** 1  
**Equipment Compliance:** N/A  
**Surface Area Compliance:** N/A

It is recommended that signage, with information including the site address, contact information for maintenance issues and emergency contact details are provided for the facility - Provide in accordance with the recommendations

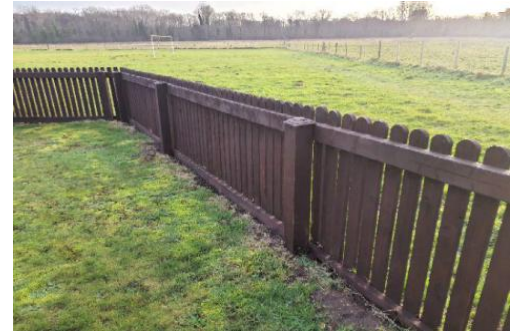
**Item:** Fencing - Timber  
**Manufacturer:** Not Identified  
**Surface Type:** Grass  
**Item Quantity:** 1  
**Equipment Compliance:** N/A  
**Surface Area Compliance:** N/A

There are a number of loose posts around the fence - Monitor for any further deterioration and reset as required

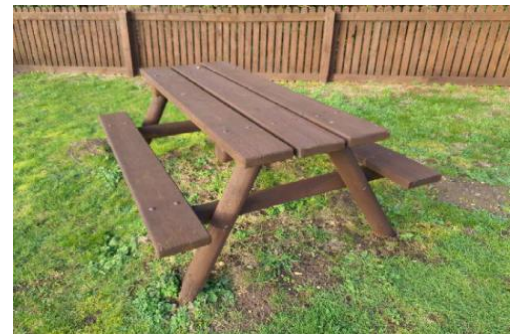
**Item:** Picnic Table  
**Manufacturer:** Not Identified  
**Surface Type:** Grass  
**Item Quantity:** 1  
**Equipment Compliance:** N/A  
**Surface Area Compliance:** N/A

There are areas or parts of the timber on the structure that have rotted - Replace all affected timbers

There is some strimmer / machinery damage apparent on the posts, this can penetrate the preservative applied to the timber and accelerate the rotting process - Monitor for any deterioration (rot) and replace as required

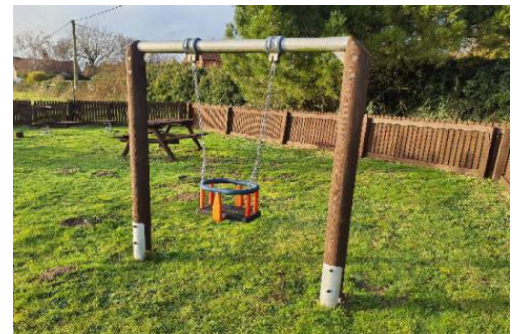
**Item:** 1 Bay 1 Seat (Cradle) - Type 1  
**Manufacturer:** Playdale Playgrounds Ltd  
**Surface Type:** Grass Matrix Tiles  
**Item Quantity:** 1  
**Equipment Compliance:** No  
**Surface Area Compliance:** Yes

This item of equipment relies on a single post, or a line of posts, for stability and extra care needs to be taken with equipment of this nature to avoid the potential for catastrophic failure; it has been checked at the time of inspection however its important that particular attention is applied on all interim inspections - Ensure that regular detailed inspections are undertaken to assess for rot, corrosion and general stability

There is some notable evidence of chain wear - Monitor for any further deterioration and replace when 40% worn

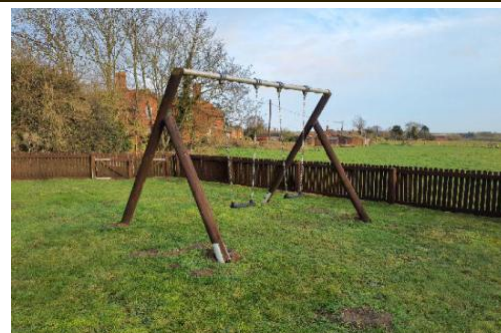
**Item:** 1 Bay 2 Seat (Flat)  
**Manufacturer:** Playdale Playgrounds Ltd  
**Surface Type:** Grass Matrix Tiles  
**Item Quantity:** 1  
**Equipment Compliance:** Yes  
**Surface Area Compliance:** Yes

There are areas or parts of the timber on the structure that have rotted - Replace all affected timbers

There is algae or moss on the surface of the equipment which can lead to the onset of rot - Clean and treat appropriately and monitor condition of the timber

There is some notable evidence of chain wear - Monitor for any further deterioration and replace when 40% worn

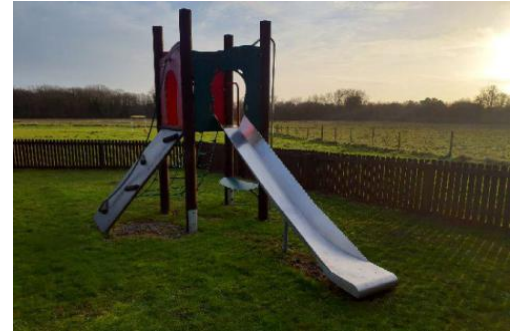
**Item:** Multi Play (Junior)  
**Manufacturer:** Playdale Playgrounds Ltd  
**Surface Type:** Grass  
**Item Quantity:** 1  
**Equipment Compliance:** Yes  
**Surface Area Compliance:** Yes

There are a number of dents in the slide surface - Monitor for any further deterioration and repair as required

There are areas or parts of the timber on the structure that have rotted - Replace all affected timbers

The ropes/nets are worn/damaged in places - Monitor for any further deterioration and repair or replace as required

The slide surface has been scratched - Monitor for any further deterioration and repair or replace as required

There is some strimmer / machinery damage apparent on the posts, this can penetrate the preservative applied to the timber and accelerate the rotting process - Monitor for any deterioration (rot) and replace as required

There is some evidence of rot in the timber - Monitor for any further deterioration and replace as required

There is/are bolt cap covers missing or damaged on the item - Replace missing or damaged bolt cap covers

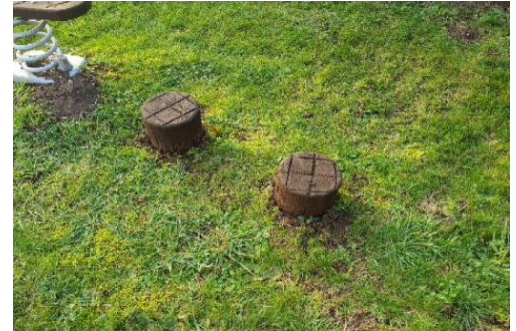
**Item:** Stepping Stones  
**Manufacturer:** Playdale Playgrounds Ltd  
**Surface Type:** Grass  
**Item Quantity:** 6  
**Equipment Compliance:** Yes  
**Surface Area Compliance:** Yes

There is some strimmer / machinery damage apparent on the posts, this can penetrate the preservative applied to the timber and accelerate the rotting process - Monitor for any deterioration (rot) and replace as required

There are areas or parts of the timber on the structure that have rotted - Replace all affected timbers

There is some evidence of rot in the timber - Monitor for any further deterioration and replace as required

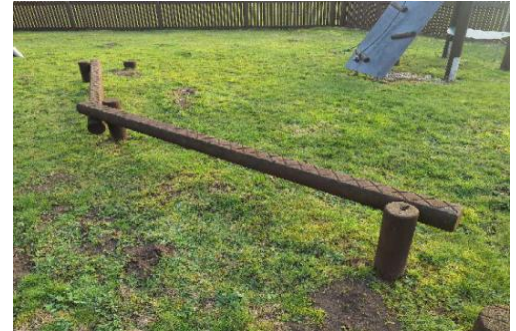
**Item:** Balance Beam  
**Manufacturer:** Playdale Playgrounds Ltd  
**Surface Type:** Grass  
**Item Quantity:** 1  
**Equipment Compliance:** Yes  
**Surface Area Compliance:** Yes

There is some strimmer / machinery damage apparent on the posts, this can penetrate the preservative applied to the timber and accelerate the rotting process - Monitor for any deterioration (rot) and replace as required

There is some evidence of rot in the timber - Monitor for any further deterioration and replace as required

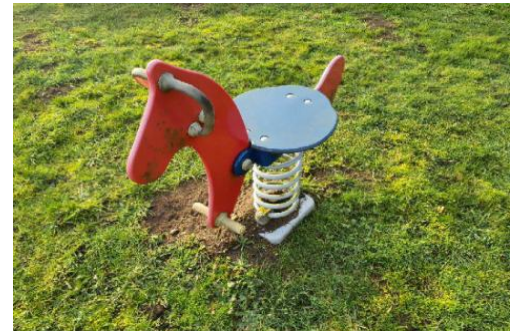
**Item:** Spring Horse  
**Manufacturer:** Ledon  
**Surface Type:** Grass  
**Item Quantity:** 1  
**Equipment Compliance:** No  
**Surface Area Compliance:** Yes

The end of handgrips and/or footrests have a cross section of less than 15cm<sup>2</sup> and fail to meet the requirements of BS EN 1176 Part 6 - Monitor - No action given the risk assessment

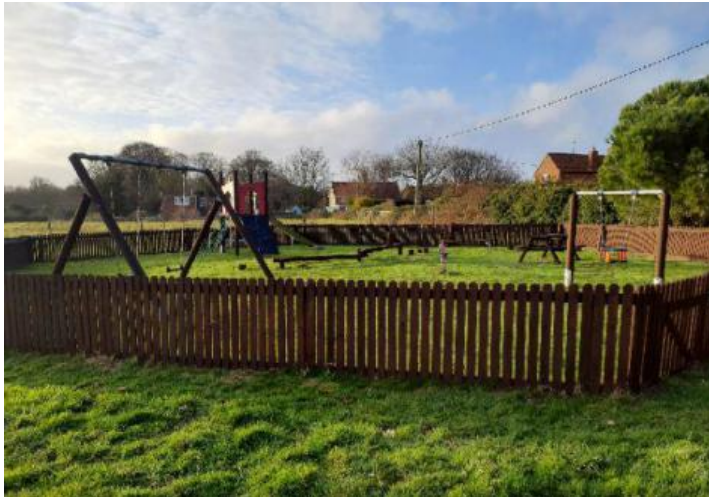
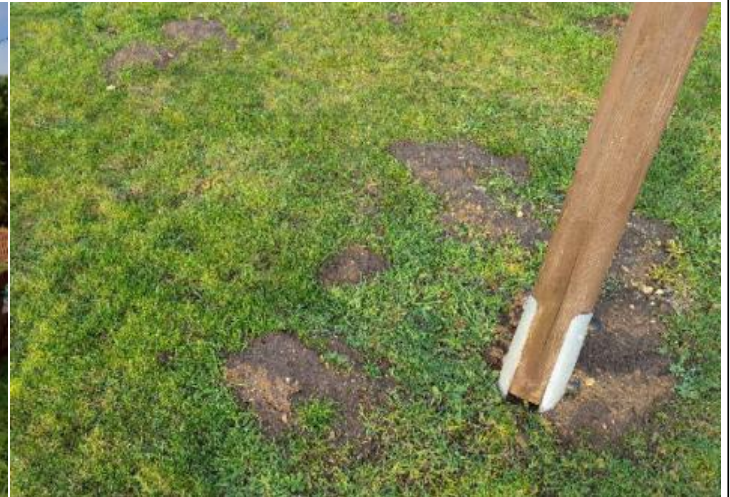
**Item:** Ancillary Items - Site General  
**Manufacturer:** Owner/Operator

**Risk Level:** L - Low Risk  
**Surface:** N/A

**Finding:** There are a number of molehills within the area and these may present unforeseen hazards for users

**Action:** Remove moles by appropriate means, reinstate surfaces to level and maintain the area

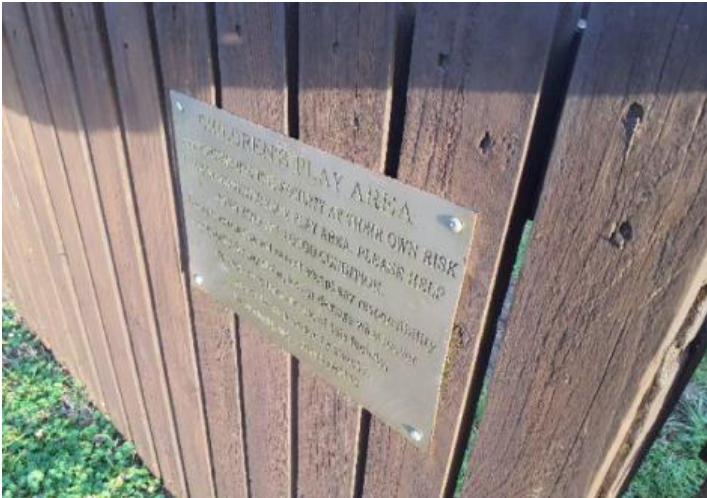
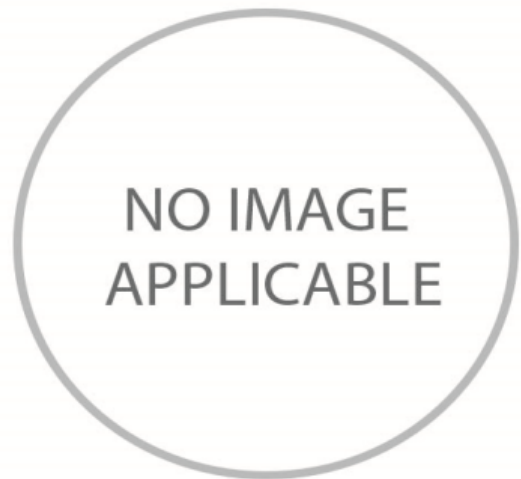
**Item:** Ancillary Items - Sign  
**Manufacturer:** Not Identified

**Risk Level:** V - Very Low Risk  
**Surface:** N/A

**Finding:** It is recommended that signage, with information including the site address, contact information for maintenance issues and emergency contact details are provided for the facility

**Action:** Provide in accordance with the recommendations

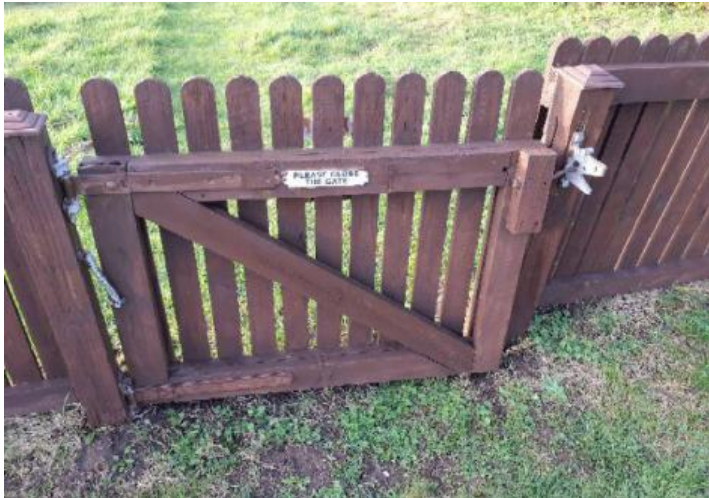
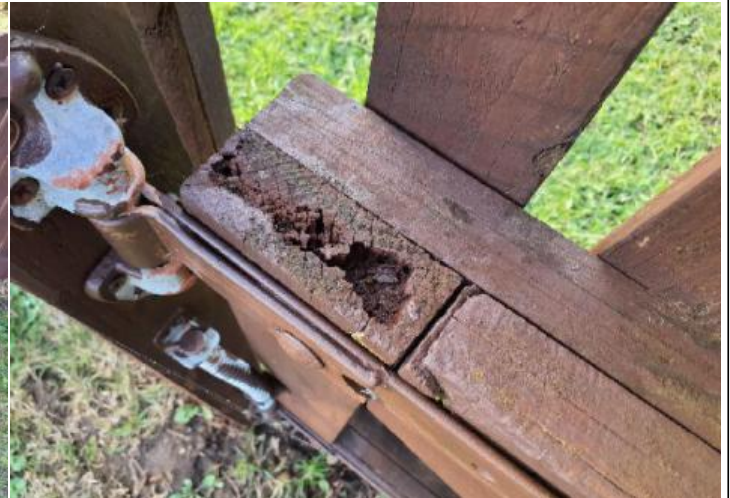
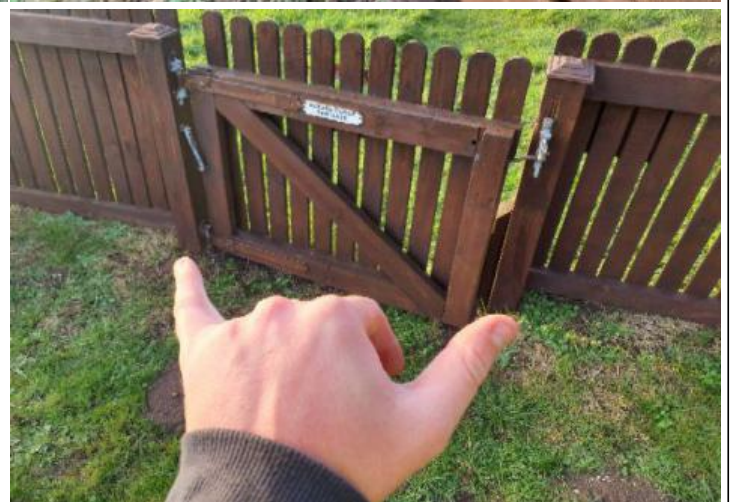
**Item:** Gates - Gate  
**Manufacturer:** Not Identified

**Risk Level:** L - Low Risk  
**Surface:** Grass

**Finding:** There are areas or parts of the timber on the structure that have rotted

**Action:** Replace all affected timbers

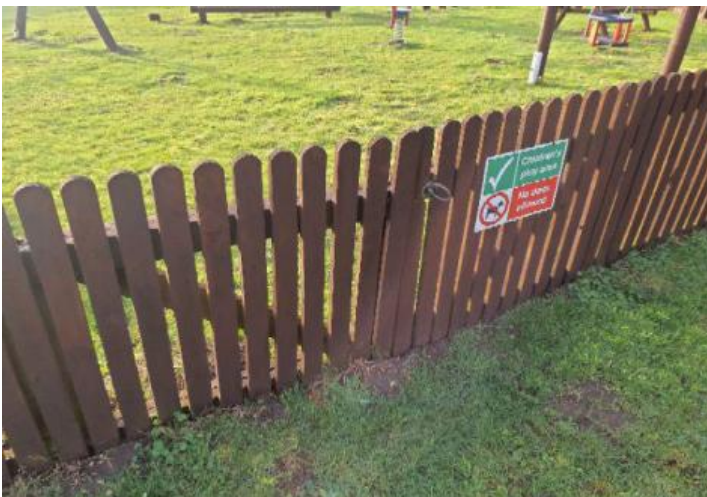
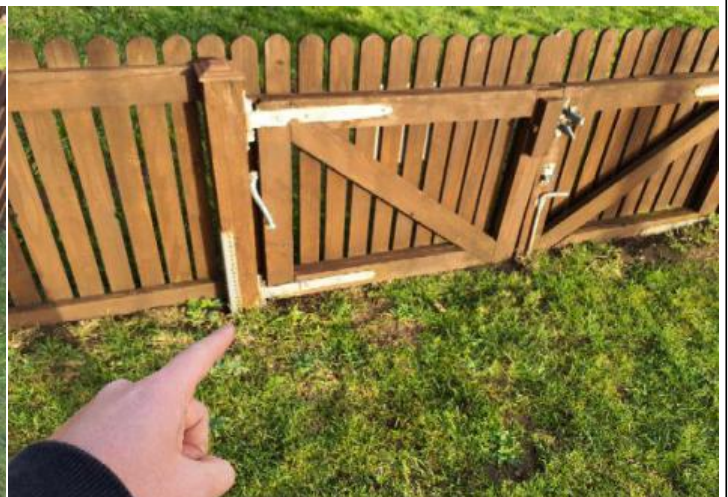
**Item:** Gates - Gate - Combination  
**Manufacturer:** Not Identified

**Risk Level:** L - Low Risk  
**Surface:** Grass

**Finding:** There are areas or parts of the timber on the structure that have rotted and snapped at ground level

**Action:** Replace all affected timbers

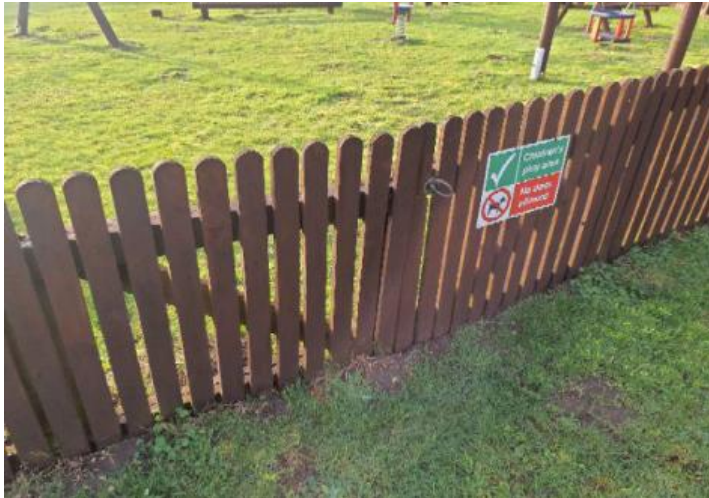
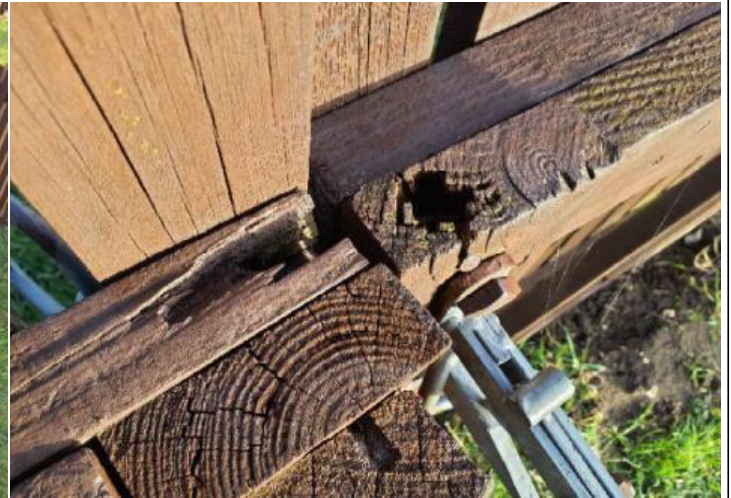
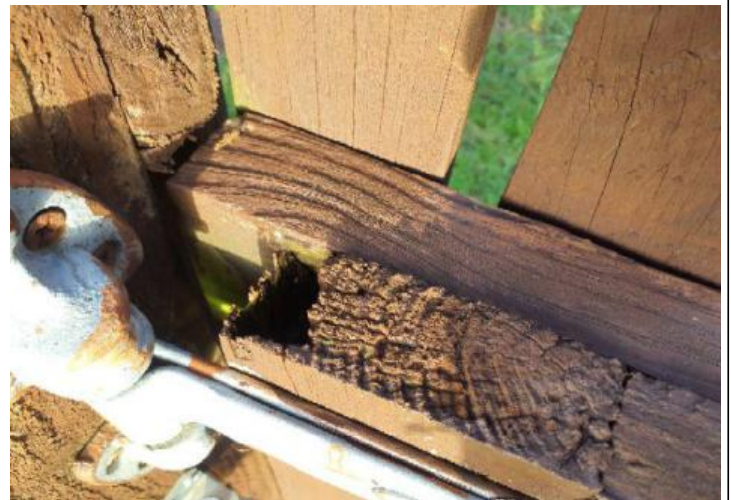
**Item:** Gates - Gate - Combination  
**Manufacturer:** Not Identified

**Risk Level:** L - Low Risk  
**Surface:** Grass

**Finding:** There are areas or parts of the timber on the structure that have rotted

**Action:** Replace all affected timbers

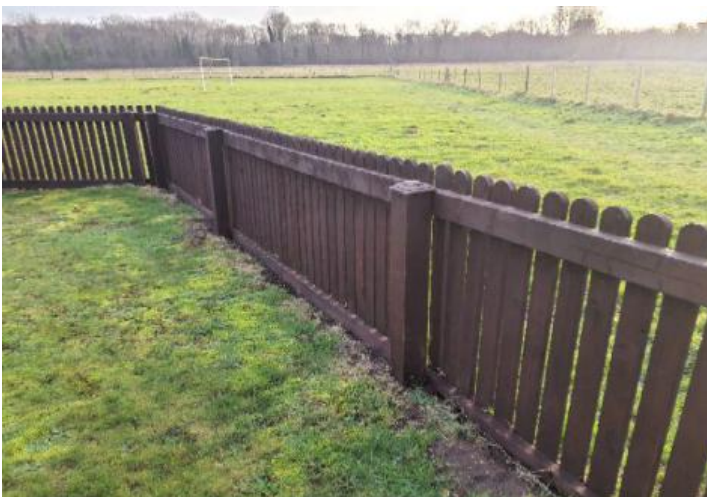
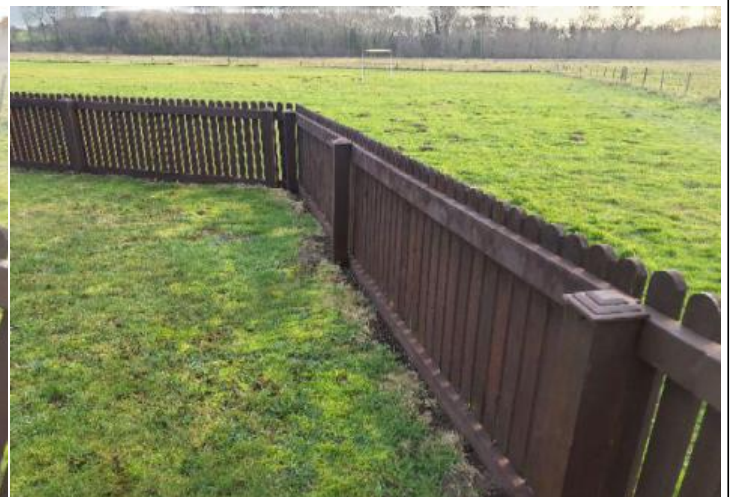
**Item:** Fences - Fencing - Timber  
**Manufacturer:** Not Identified

**Risk Level:** L - Low Risk  
**Surface:** Grass

**Finding:** There are a number of loose posts around the fence

**Action:** Monitor for any further deterioration and reset as required

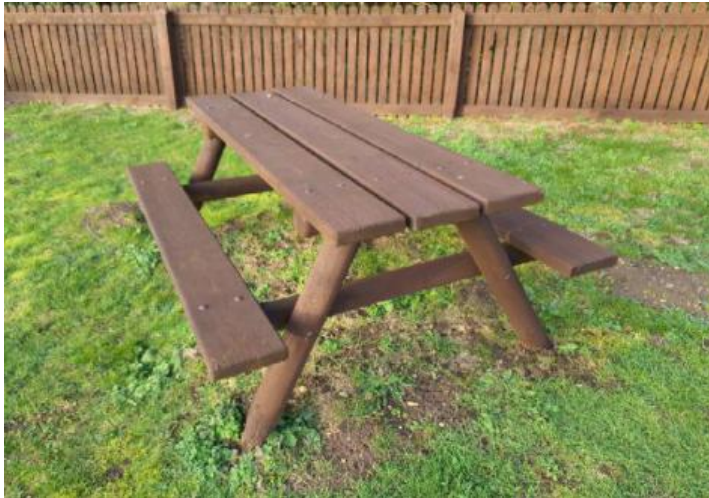
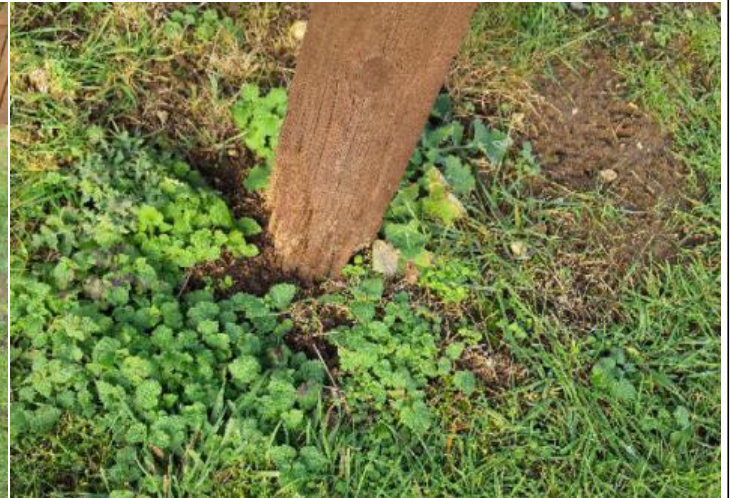
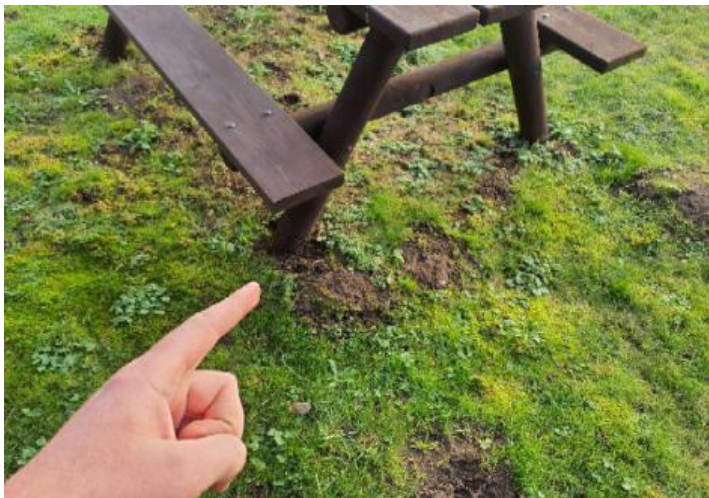
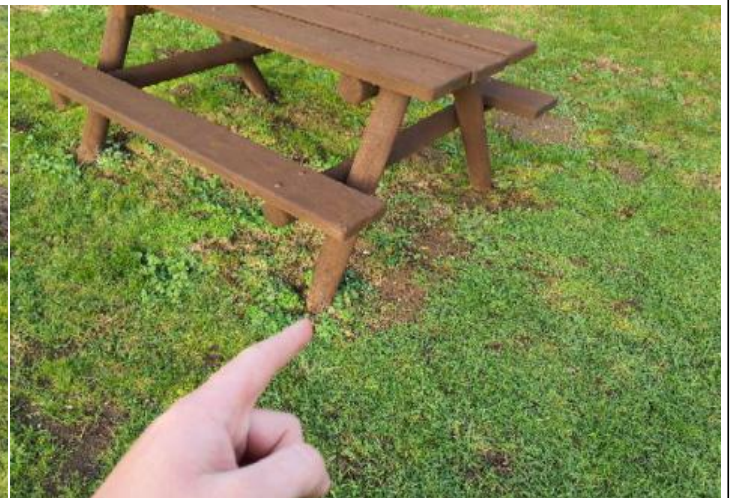
**Item:** Ancillary Items - Picnic Table  
**Manufacturer:** Not Identified

**Risk Level:** L - Low Risk  
**Surface:** Grass

**Finding:** There are areas or parts of the timber on the structure that have rotted

**Action:** Replace all affected timbers

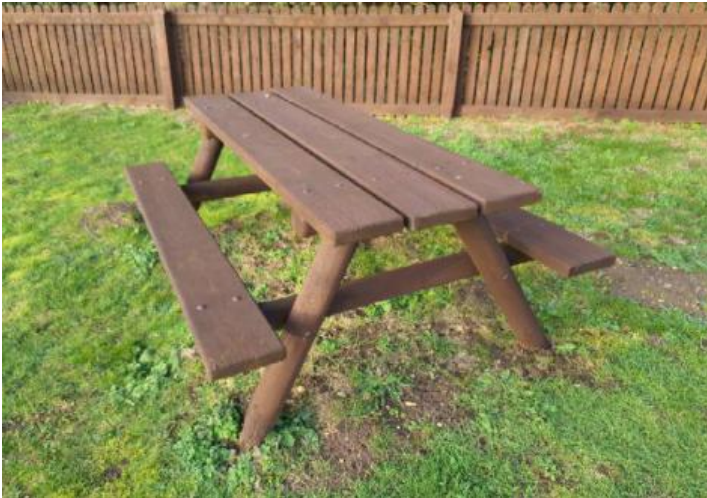
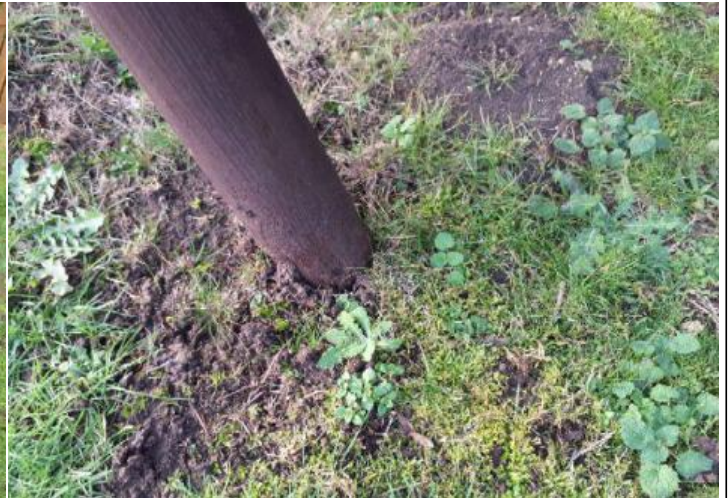
**Item:** Ancillary Items - Picnic Table  
**Manufacturer:** Not Identified

**Risk Level:** L - Low Risk  
**Surface:** Grass

**Finding:** There is some strimmer / machinery damage apparent on the posts, this can penetrate the preservative applied to the timber and accelerate the rotting process

**Action:** Monitor for any deterioration (rot) and replace as required

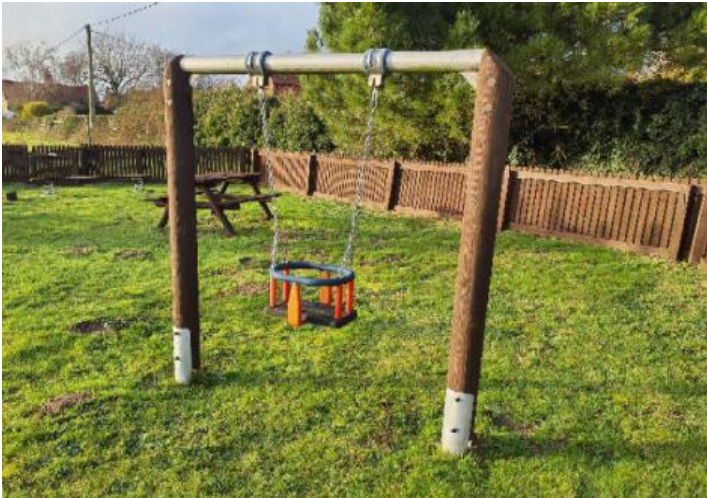
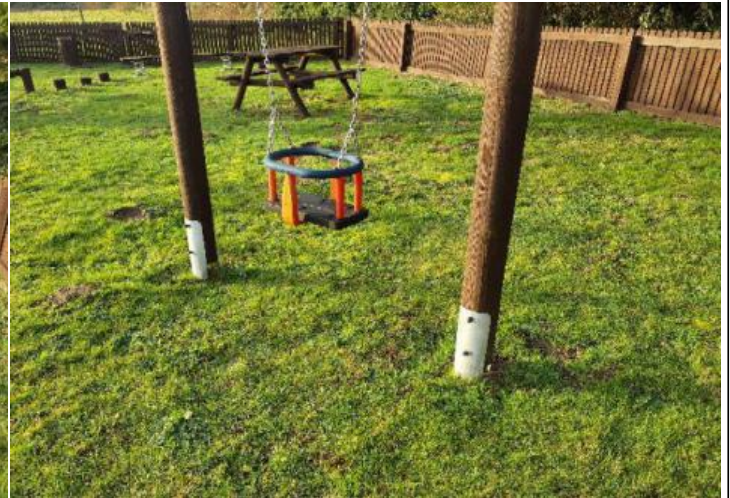
**Item:** Swings - 1 Bay 1 Seat (Cradle) - Type 1  
**Manufacturer:** Playdale Playgrounds Ltd

**Risk Level:** N - Risk Assessment not Undertaken  
**Surface:** Grass Matrix Tiles

**Finding:** This item of equipment relies on a single post, or a line of posts, for stability and extra care needs to be taken with equipment of this nature to avoid the potential for catastrophic failure; it has been checked at the time of inspection however its important that particular attention is applied on all interim inspections

**Action:** Ensure that regular detailed inspections are undertaken to assess for rot, corrosion and general stability

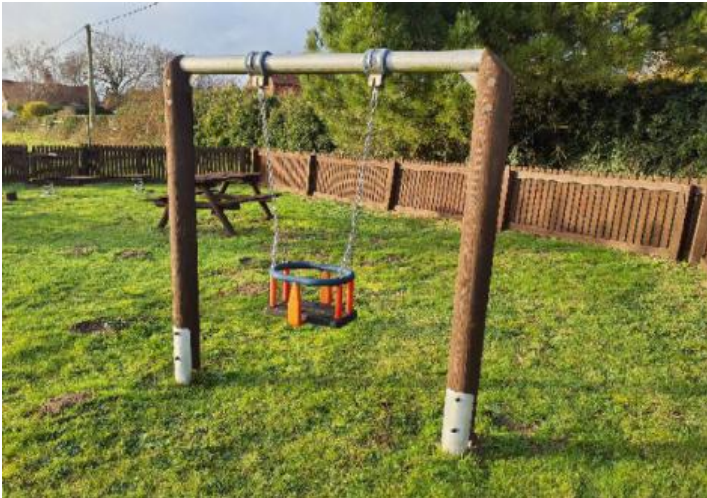
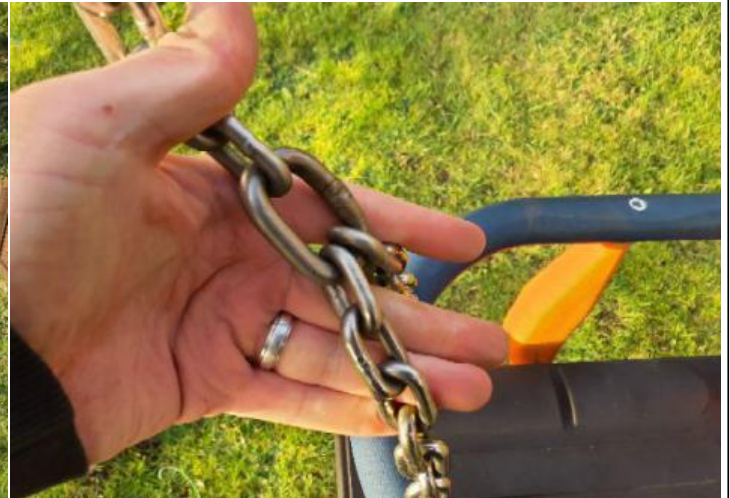
**Item:** Swings - 1 Bay 1 Seat (Cradle) - Type 1  
**Manufacturer:** Playdale Playgrounds Ltd

**Risk Level:** L - Low Risk  
**Surface:** Grass Matrix Tiles

**Finding:** There is some notable evidence of chain wear

**Action:** Monitor for any further deterioration and replace when 40% worn

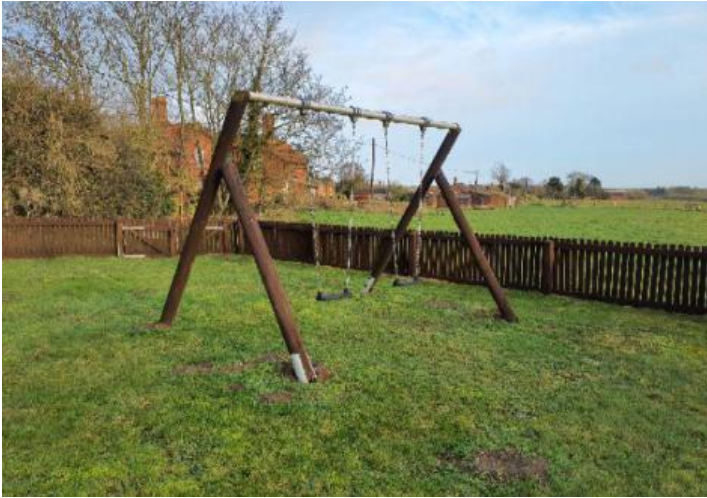
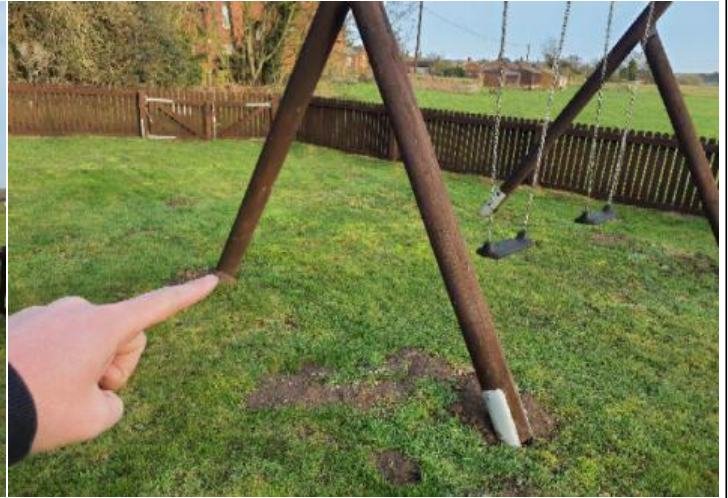
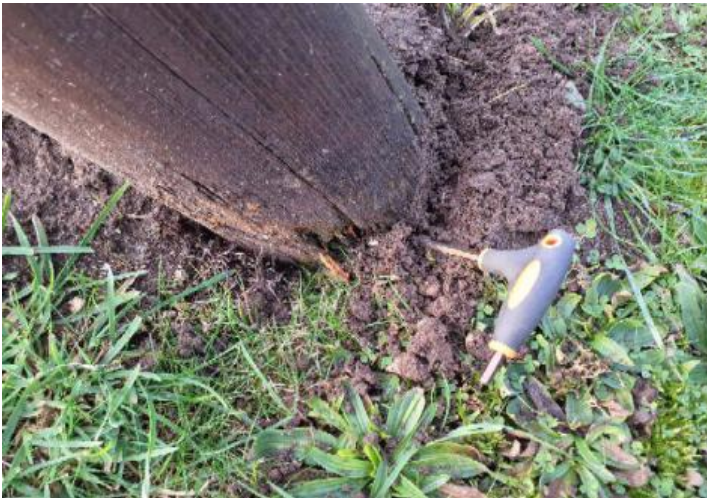
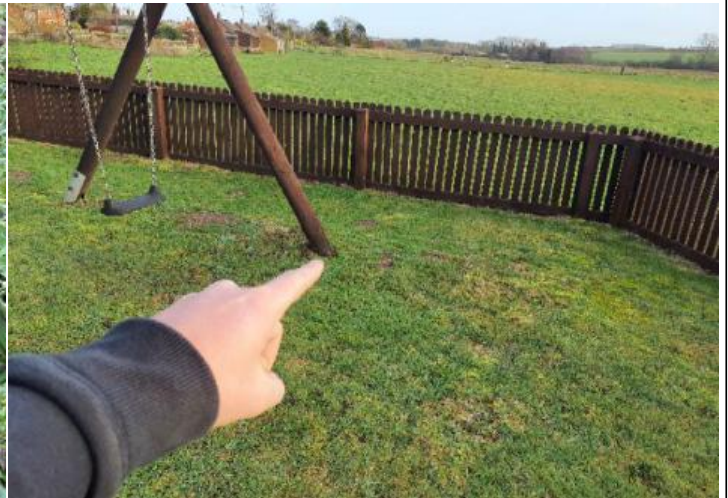
**Item:** Swings - 1 Bay 2 Seat (Flat)  
**Manufacturer:** Playdale Playgrounds Ltd

**Risk Level:** M - Moderate Risk  
**Surface:** Grass Matrix Tiles

**Finding:** There are areas or parts of the timber on the structure that have rotted

**Action:** Replace all affected timbers

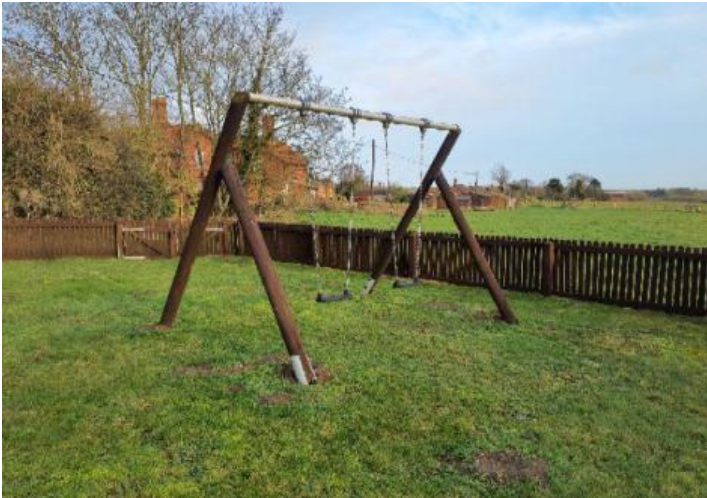
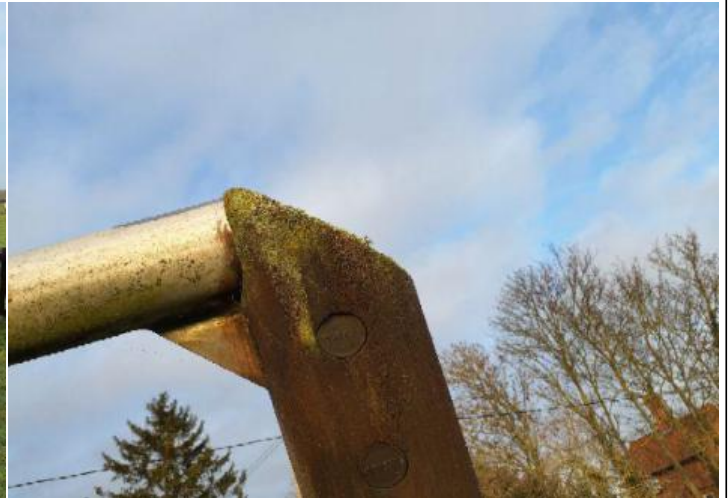
**Item:** Swings - 1 Bay 2 Seat (Flat)  
**Manufacturer:** Playdale Playgrounds Ltd

**Risk Level:** L - Low Risk  
**Surface:** Grass Matrix Tiles

**Finding:** There is algae or moss on the surface of the equipment which can lead to the onset of rot

**Action:** Clean and treat appropriately and monitor condition of the timber

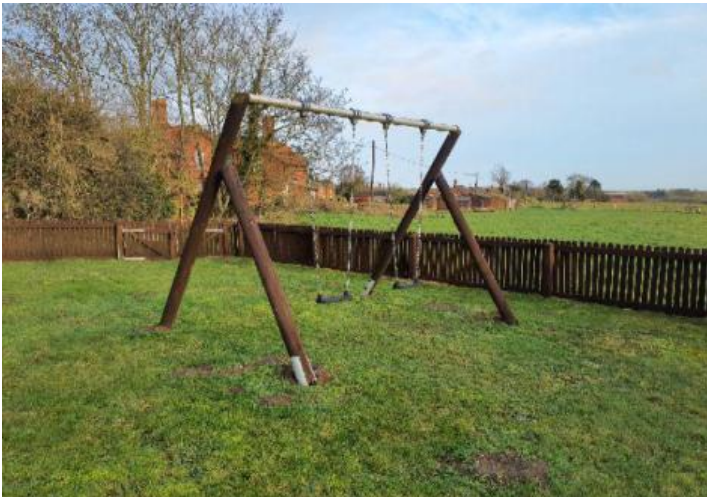
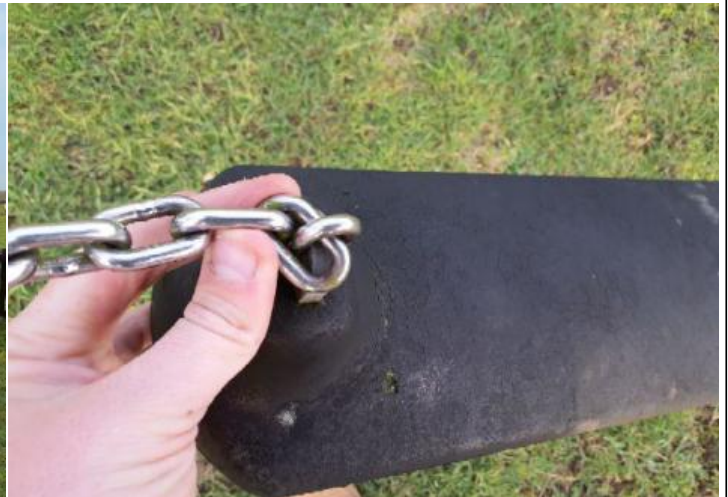
**Risk Level:** L - Low Risk  
**Surface:** Grass Matrix Tiles

**Finding:** There is some notable evidence of chain wear

**Action:** Monitor for any further deterioration and replace when 40% worn

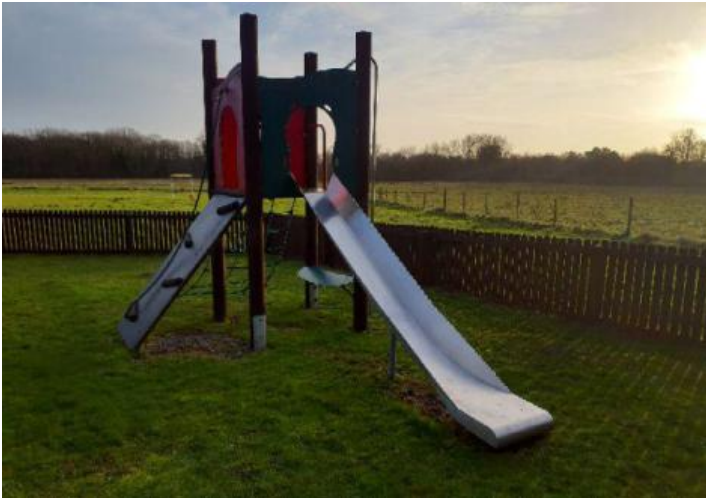
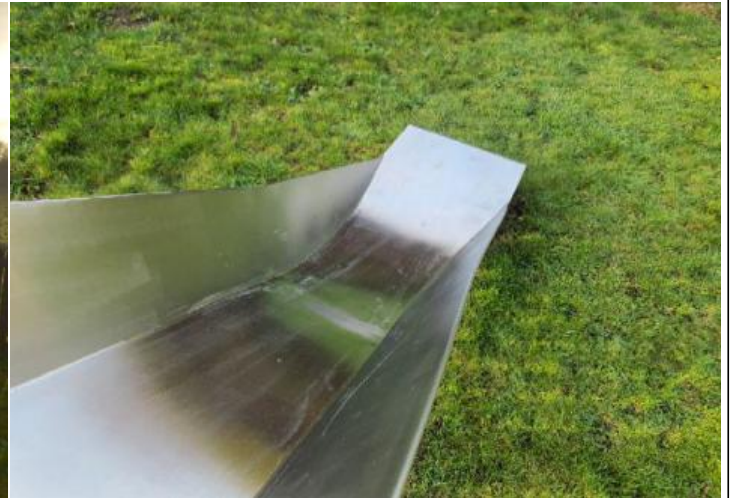
**Risk Level:** V - Very Low Risk  
**Surface:** Grass

**Finding:** There are a number of dents in the slide surface

**Action:** Monitor for any further deterioration and repair as required

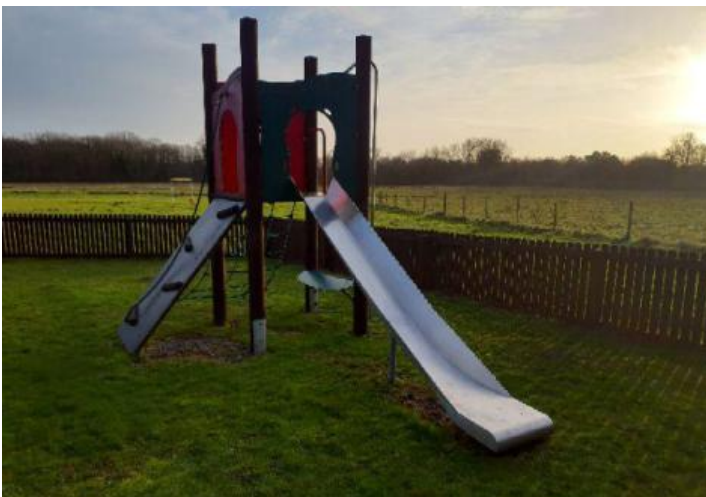
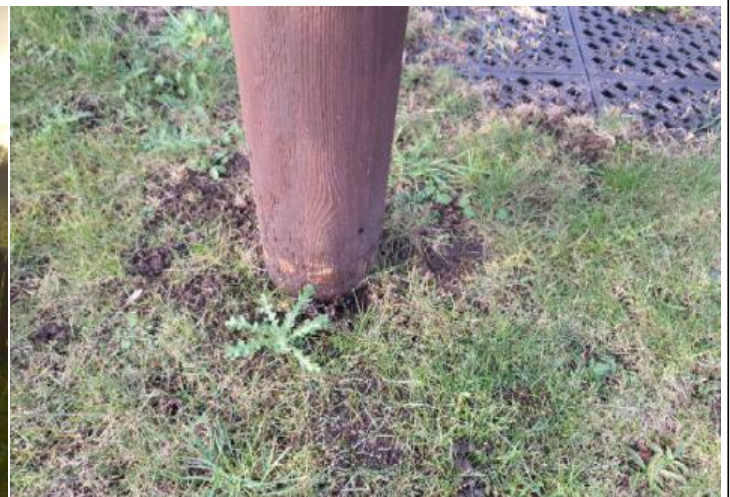
**Risk Level:** L - Low Risk  
**Surface:** Grass

**Finding:** There is some strimmer / machinery damage apparent on the posts, this can penetrate the preservative applied to the timber and accelerate the rotting process

**Action:** Monitor for any deterioration (rot) and replace as required

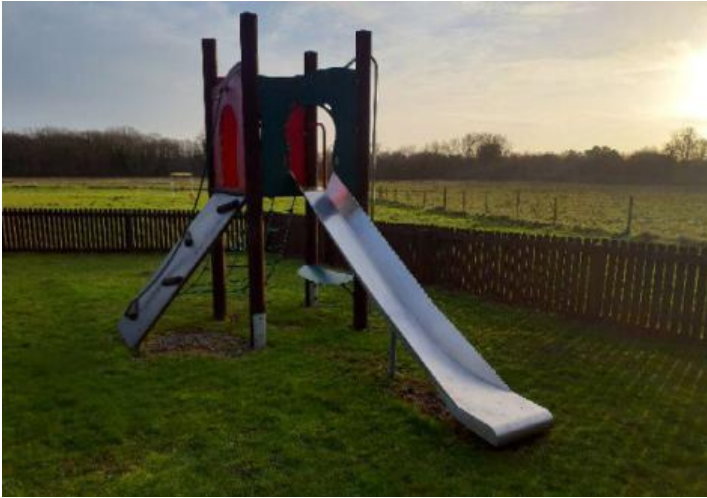
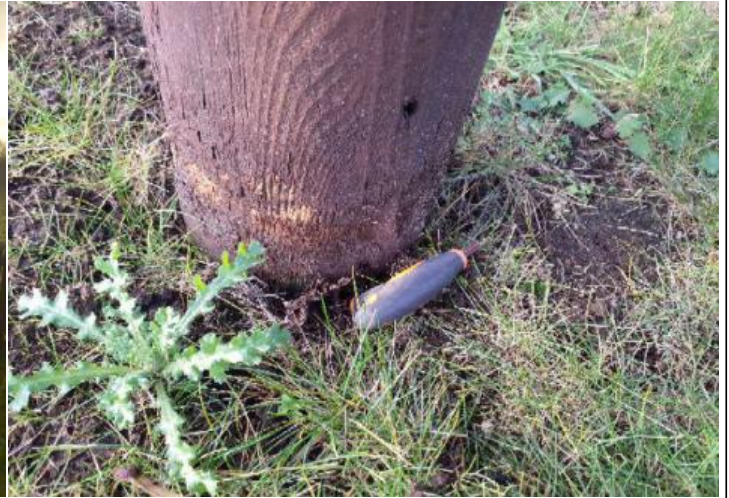
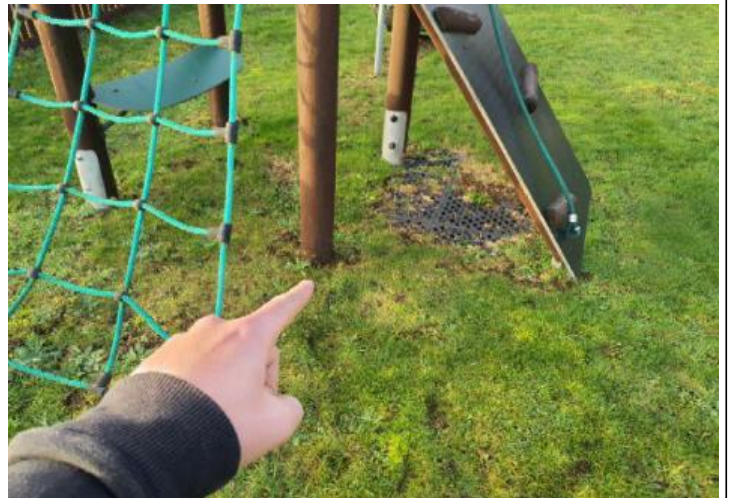
**Risk Level:** M - Moderate Risk  
**Surface:** Grass

**Finding:** There are areas or parts of the timber on the structure that have rotted

**Action:** Replace all affected timbers

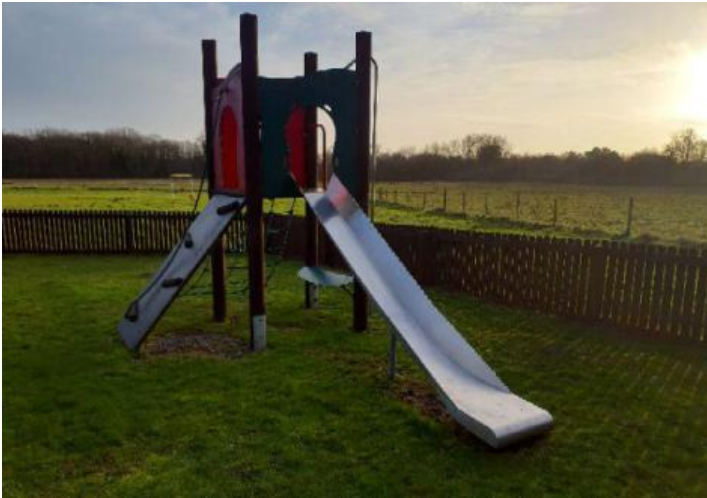
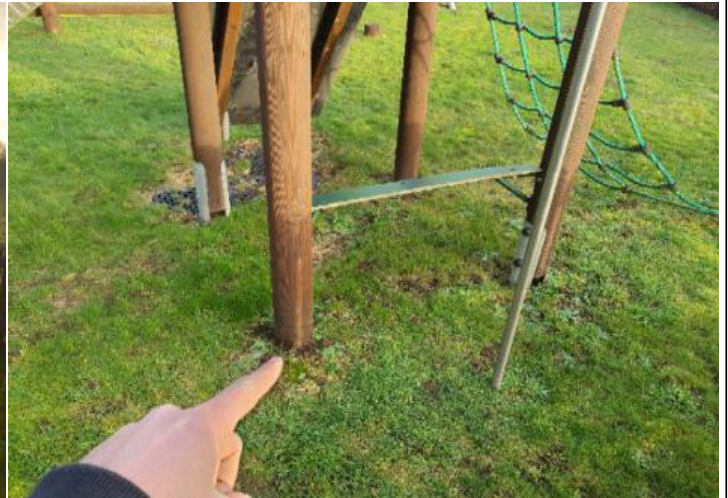
**Risk Level:** L - Low Risk  
**Surface:** Grass

**Finding:** There is some evidence of rot in the timber

**Action:** Monitor for any further deterioration and replace as required

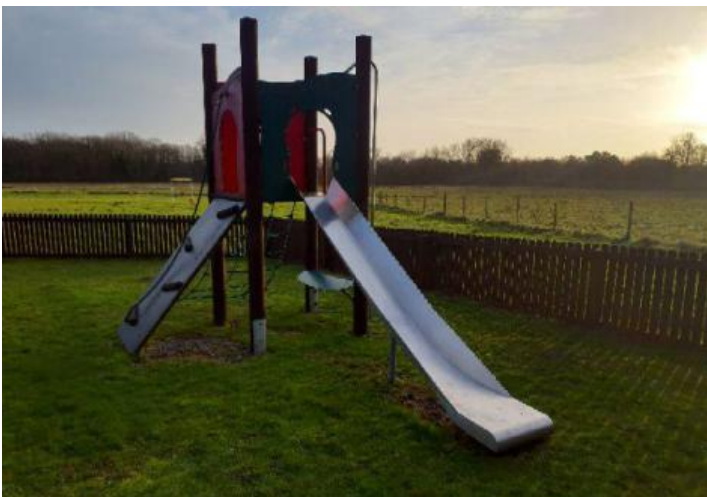
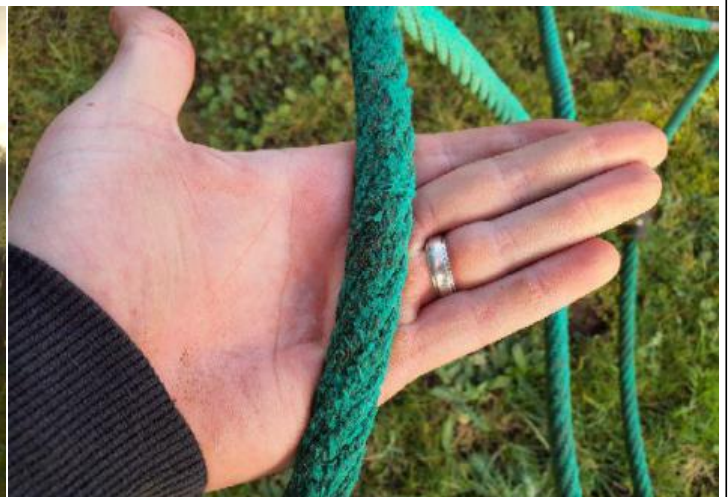
**Risk Level:** L - Low Risk  
**Surface:** Grass

**Finding:** The ropes/nets are worn/damaged in places

**Action:** Monitor for any further deterioration and repair or replace as required

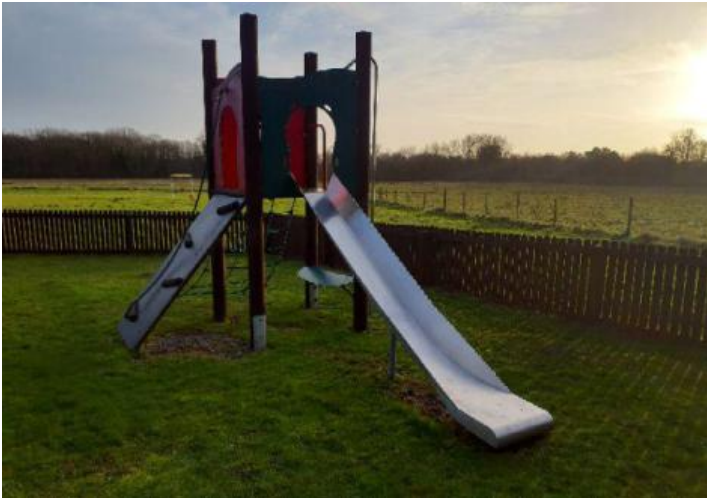
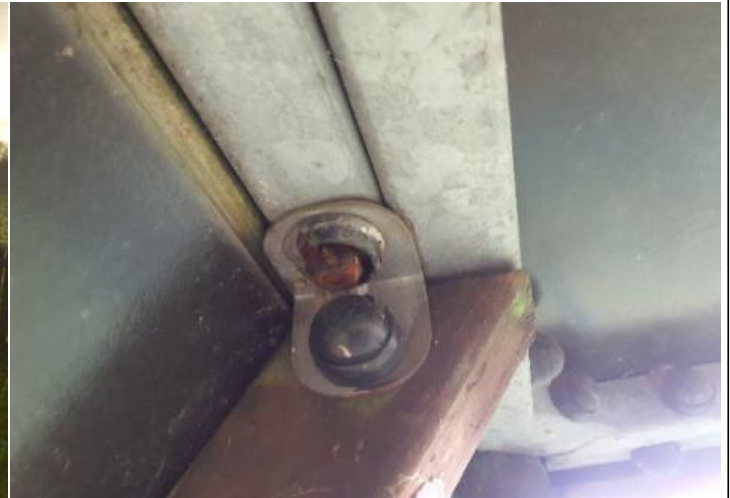
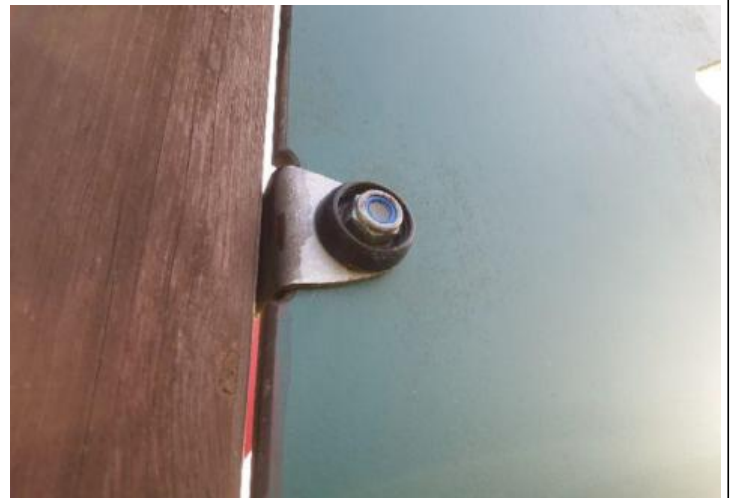
**Risk Level:** V - Very Low Risk  
**Surface:** Grass

**Finding:** There is/are bolt cap covers missing or damaged on the item

**Action:** Replace missing or damaged bolt cap covers

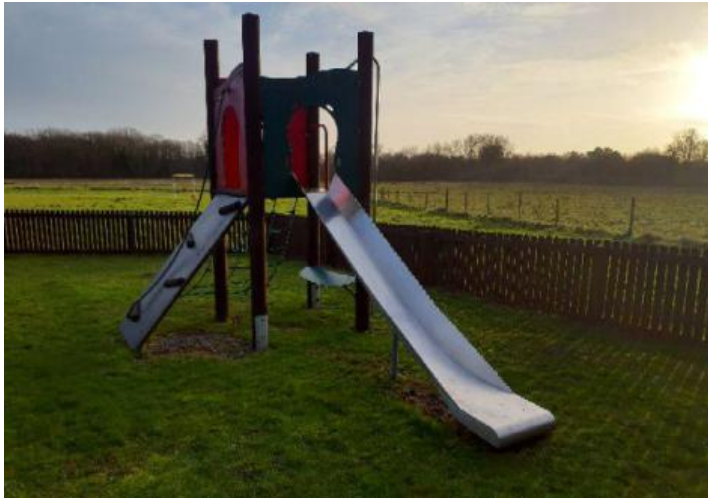
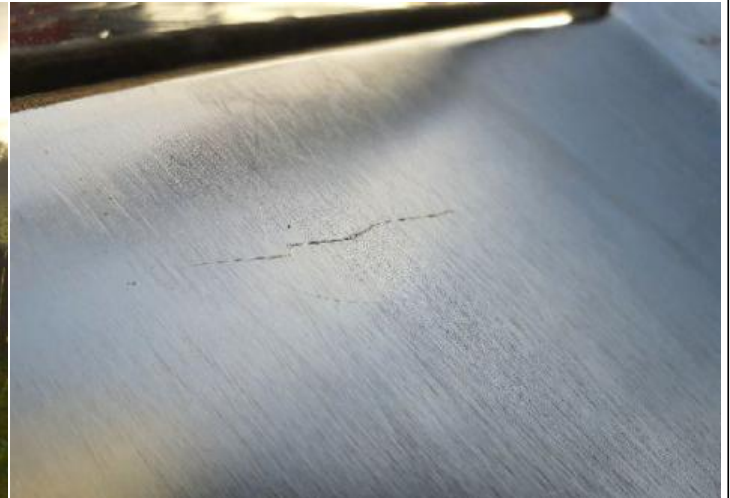
**Risk Level:** L - Low Risk  
**Surface:** Grass

**Finding:** The slide surface has been scratched

**Action:** Monitor for any further deterioration and repair or replace as required

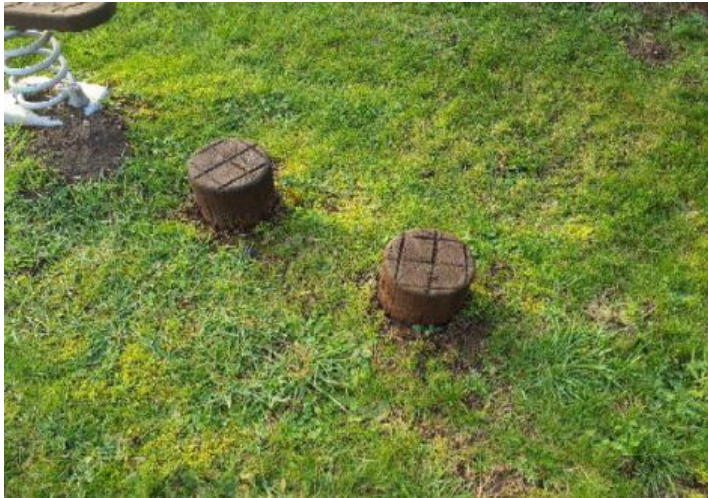
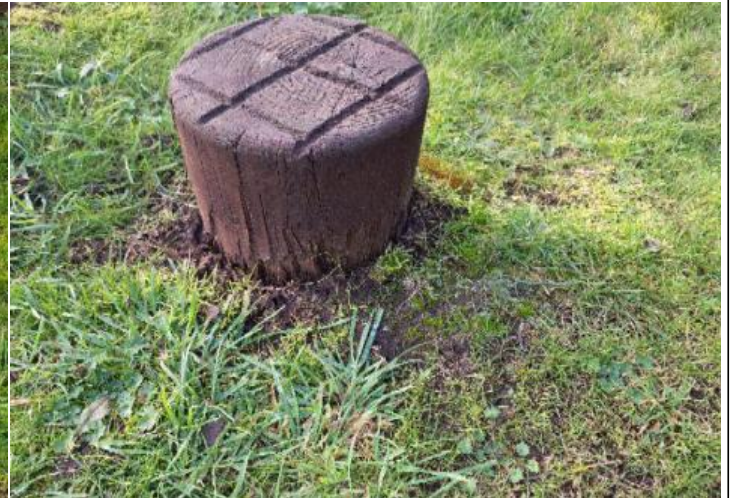
**Risk Level:** L - Low Risk  
**Surface:** Grass

**Finding:** There is some strimmer / machinery damage apparent on the posts, this can penetrate the preservative applied to the timber and accelerate the rotting process

**Action:** Monitor for any deterioration (rot) and replace as required
