## Annual Inspection

Flitcham cum Appleton Parish Council

Flitcham cum Appleton

Abbey Road, Nr King's Lynn, Norfolk, PE31 6BT

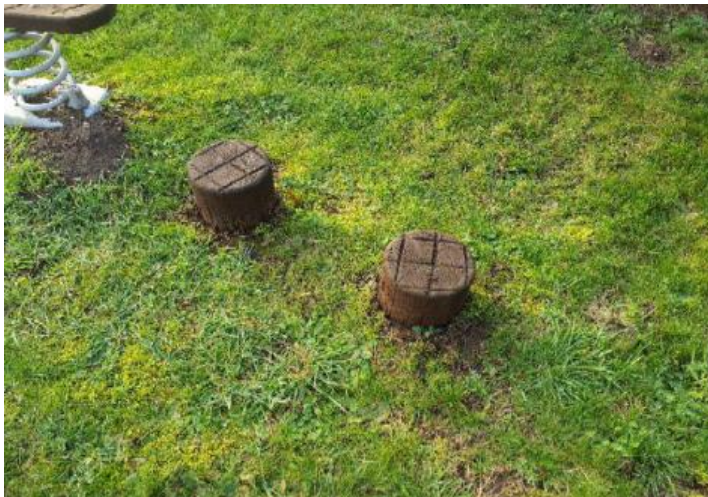
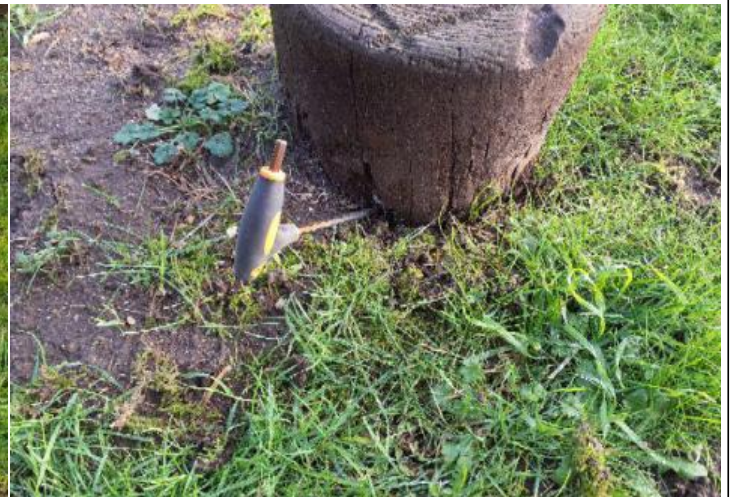
**Risk Level:** L - Low Risk  
**Surface:** Grass

**Finding:** There is some evidence of rot in the timber

**Action:** Monitor for any further deterioration and replace as required

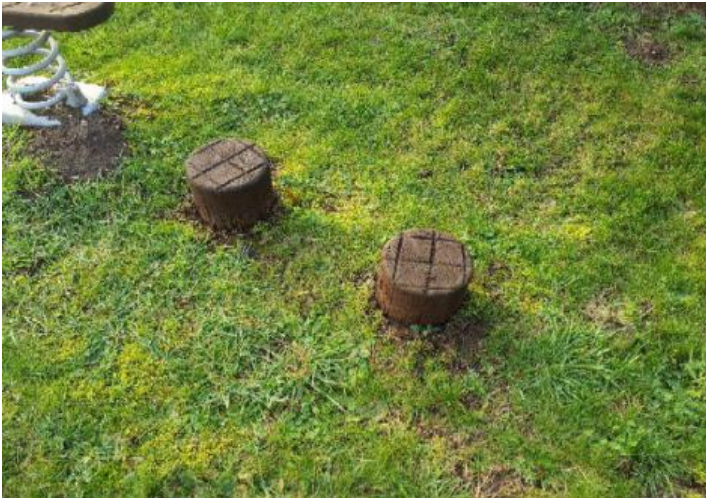
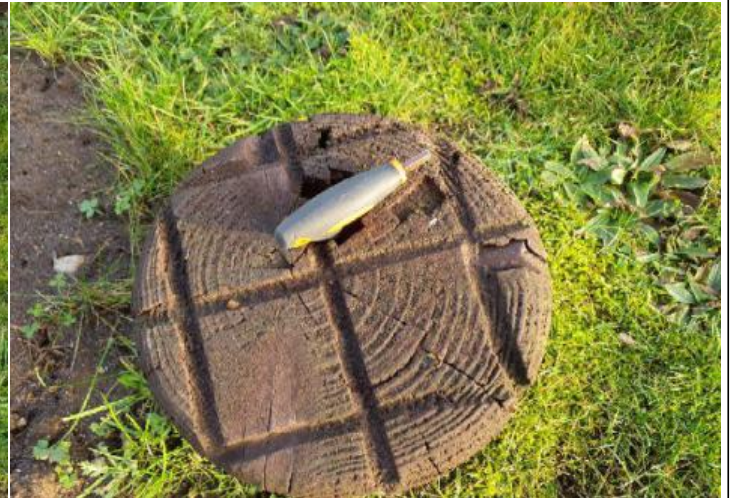
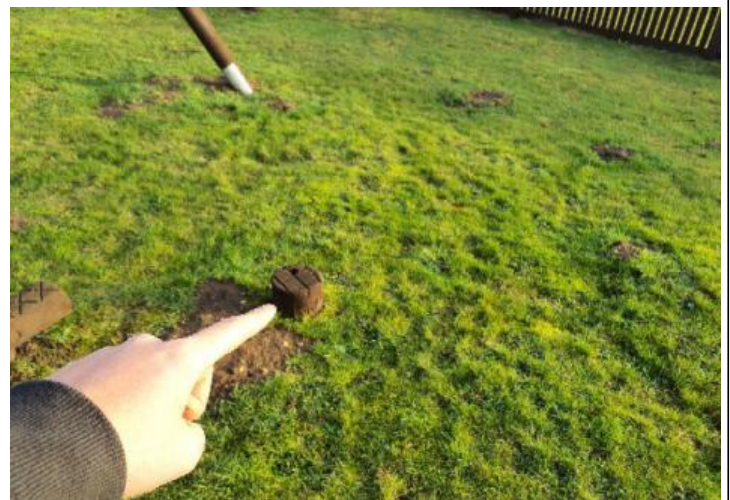
**Risk Level:** L - Low Risk  
**Surface:** Grass

**Finding:** There are areas or parts of the timber on the structure that have rotted

**Action:** Replace all affected timbers

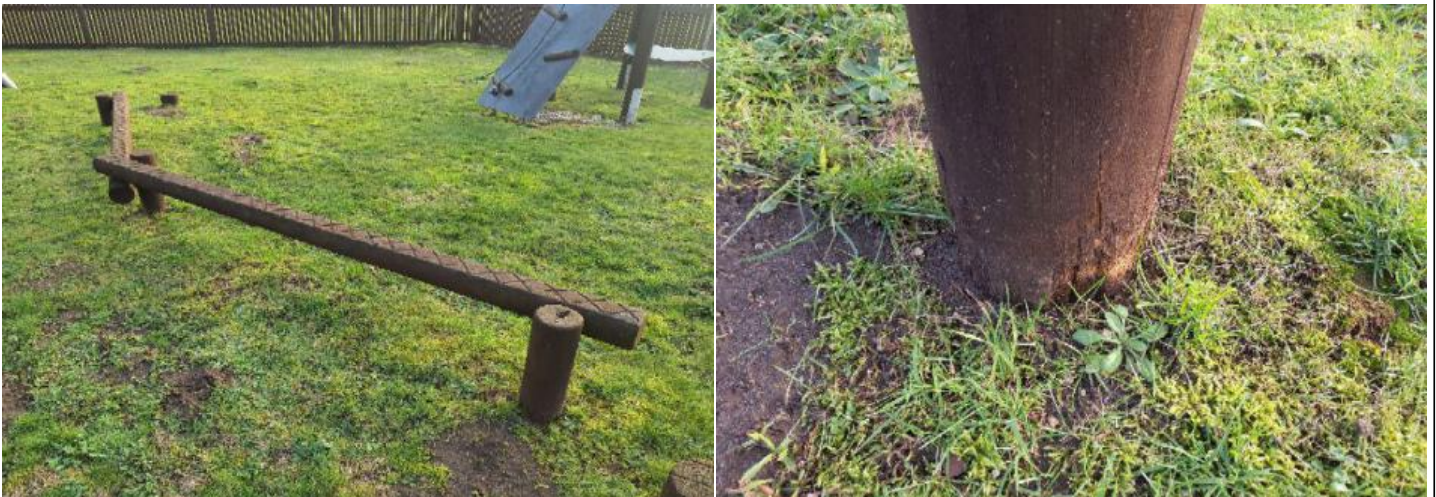
**Item:** Activity Equipment - Balance Beam  
**Manufacturer:** Playdale Playgrounds Ltd  
**Risk Level:** L - Low Risk  
**Surface:** Grass

**Finding:** There is some strimmer / machinery damage apparent on the posts, this can penetrate the preservative applied to the timber and accelerate the rotting process  
**Action:** Monitor for any deterioration (rot) and replace as required

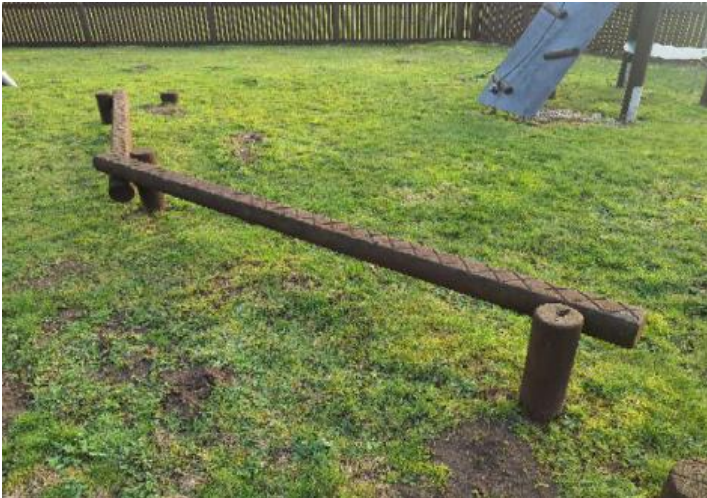
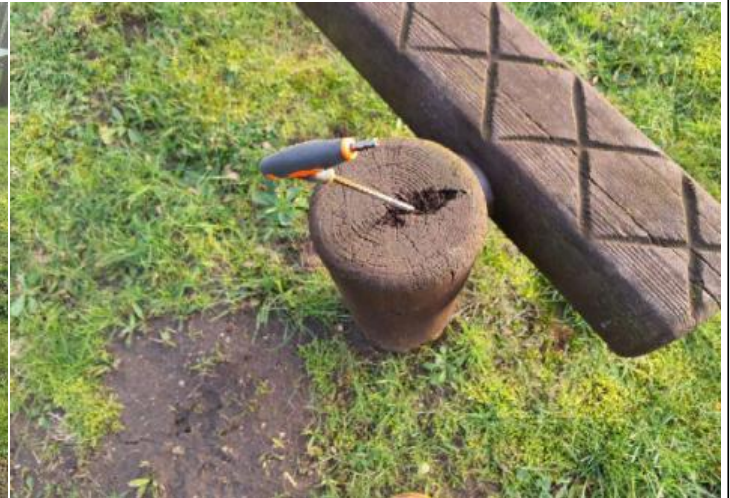
**Risk Level:** L - Low Risk  
**Surface:** Grass

**Finding:** There is some evidence of rot in the timber

**Action:** Monitor for any further deterioration and replace as required

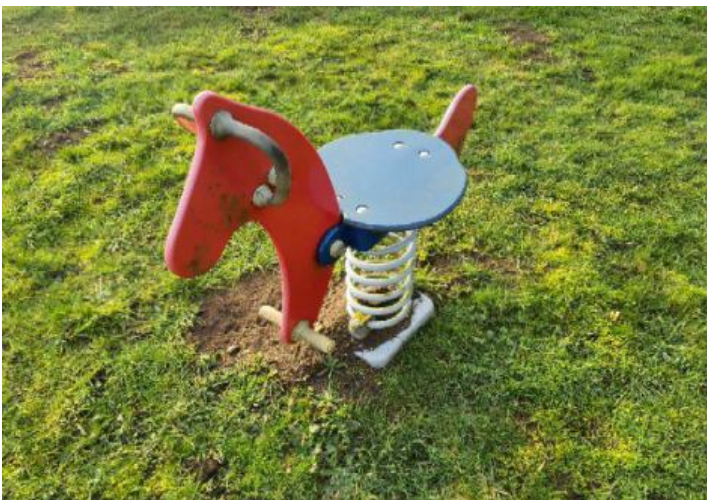
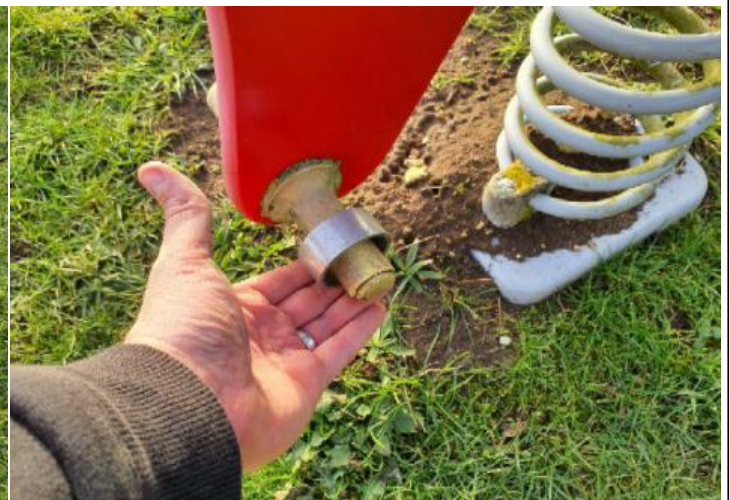
**Risk Level:** L - Low Risk  
**Surface:** Grass

**Finding:** The end of handgrips and/or footrests have a cross section of less than 15cm<sup>2</sup> and fail to meet the requirements of BS EN 1176 Part 6

**Action:** Monitor - No action given the risk assessment
