## Annual Inspection

Flitcham cum Appleton Parish Council

Flitcham cum Appleton

Abbey Road, Nr King's Lynn, Norfolk, PE31 6BT

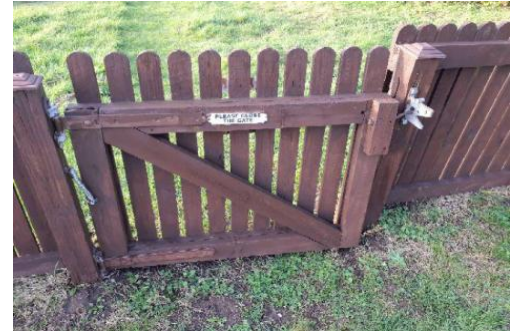
**Item:** Gate  
**Manufacturer:** Not Identified  
**Surface Type:** Grass  
**Item Quantity:** 1  
**Equipment Compliance:** N/A  
**Surface Area Compliance:** N/A

The gate is snagging on the surrounding surface preventing it from closing correctly - Carry out remedial works to ensure the gate closes correctly

There are areas or parts of the timber on the structure that have rotted - Replace all affected timbers

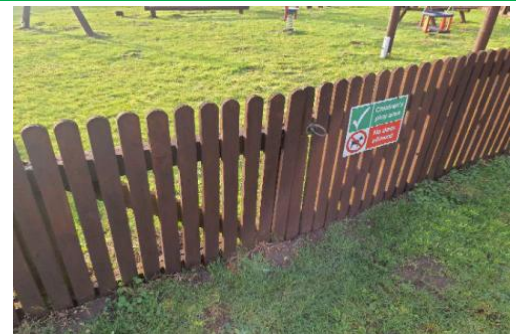
**Item:** Gate - Combination  
**Manufacturer:** Not Identified  
**Surface Type:** Grass  
**Item Quantity:** 1  
**Equipment Compliance:** N/A  
**Surface Area Compliance:** N/A

There is no padlock on the maintenance gate - Provide a padlock to secure the gate

There are areas or parts of the timber on the structure that have rotted and snapped at ground level - Replace all affected timbers

There are areas or parts of the timber on the structure that have rotted - Replace all affected timbers

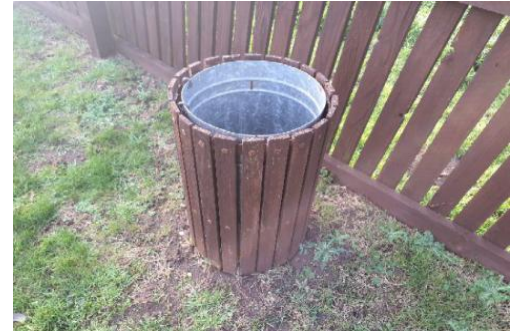
**Item:** Litter Bin  
**Manufacturer:** Not Identified  
**Surface Type:** Grass  
**Item Quantity:** 1  
**Equipment Compliance:** N/A  
**Surface Area Compliance:** N/A

The liner of the litter bin is not secured and can be easily removed - Ensure the liner is secured

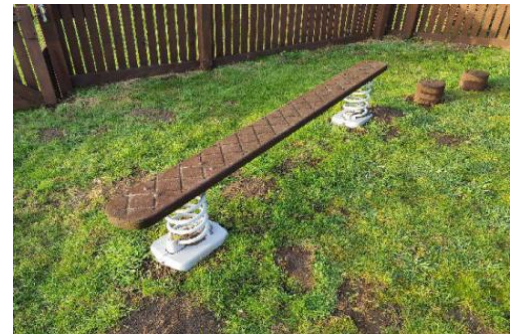
**Item:** Spring Balance Beam  
**Manufacturer:** Playdale Playgrounds Ltd  
**Surface Type:** Grass  
**Item Quantity:** 1  
**Equipment Compliance:** No  
**Surface Area Compliance:** Yes

The gate when opened forms a projecting obstacle / hard object within the falling space of the equipment, in contravention of the requirements of BS EN 1176 Part 1 - Monitor - No action given the risk assessment

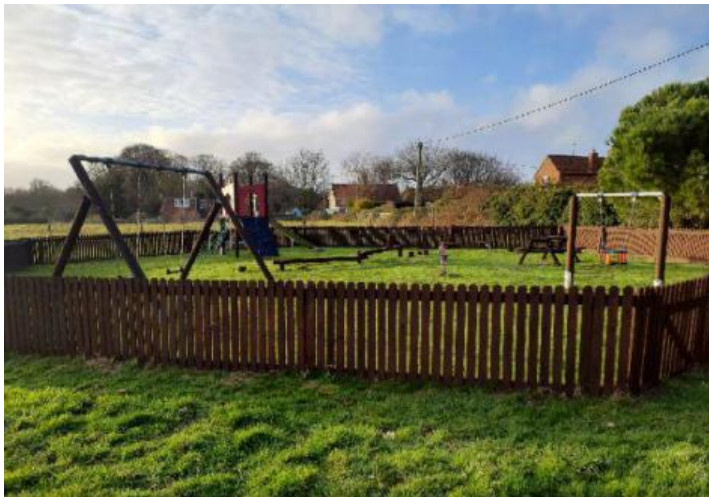
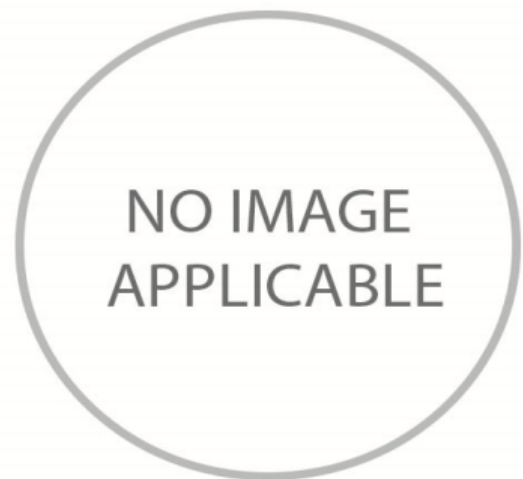
**Item:** Ancillary Items - Site General  
**Manufacturer:** Owner/Operator

**Finding:** NOTE - The client was made aware of any findings with a risk score of 15 and above at the time of the inspection, due to the urgency of action required.

**Action:** Ensure appropriate action is, or has already been taken.

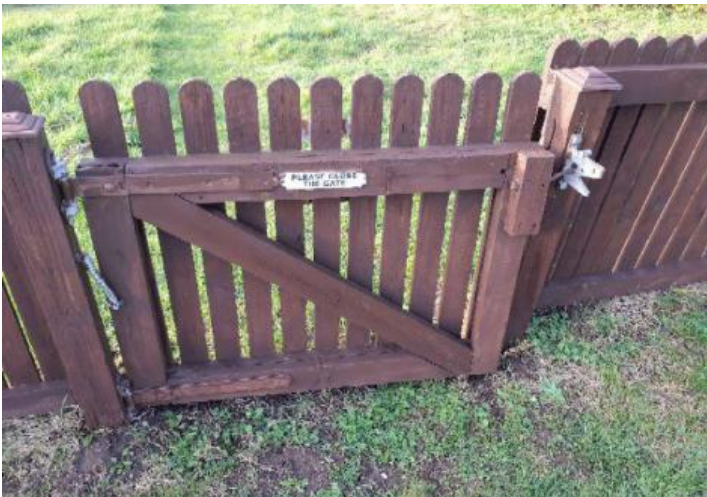
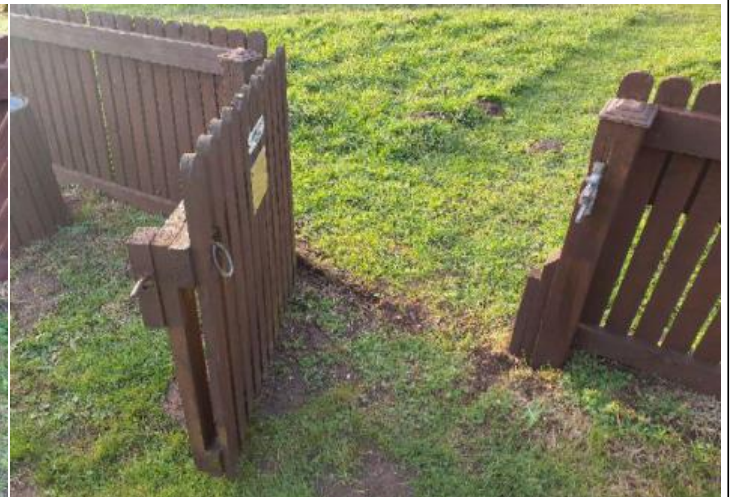
**Item:** Gates - Gate  
**Manufacturer:** Not Identified

**Finding:** The gate is snagging on the surrounding surface preventing it from closing correctly

**Action:** Carry out remedial works to ensure the gate closes correctly

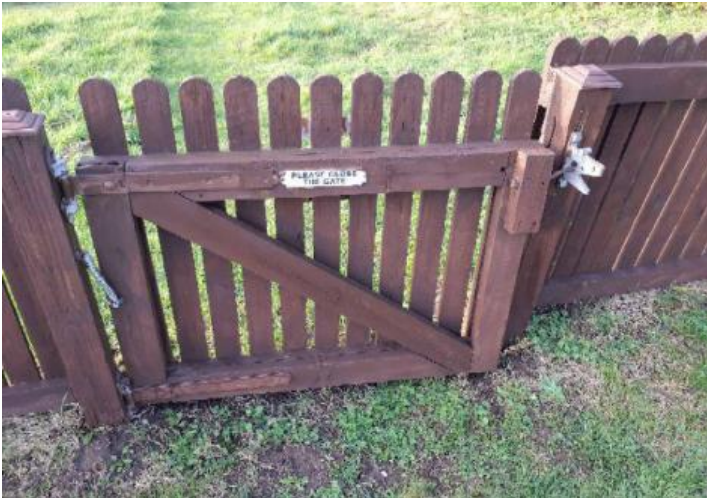
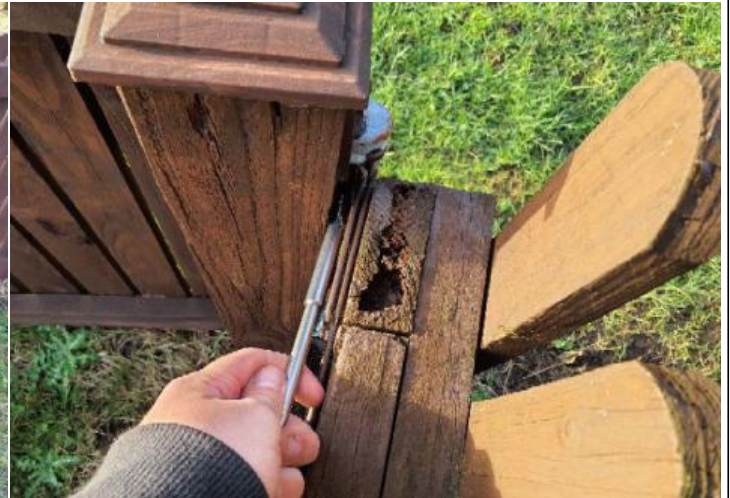
**Item:** Gates - Gate  
**Manufacturer:** Not Identified

**Finding:** There are openings that are less than 12mm that could trap or crush fingers

**Action:** Provide a 12mm gap throughout full range of motion at both sides of gate

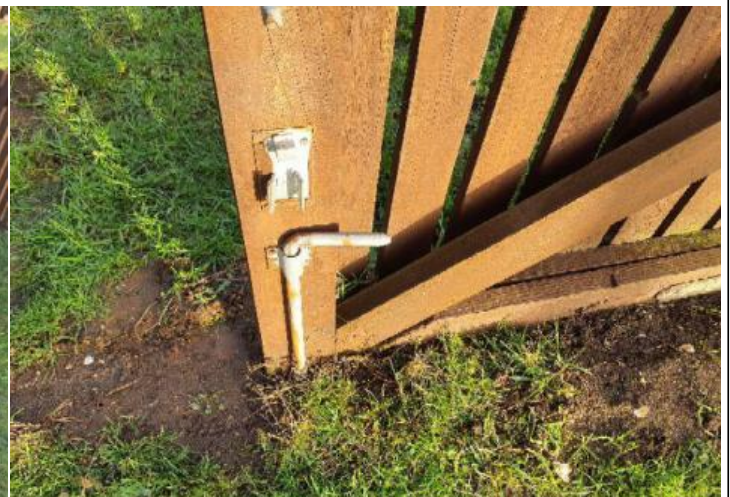
**Item:** Gates - Gate - Combination  
**Manufacturer:** Not Identified

**Finding:** There is no padlock on the maintenance gate

**Action:** Provide a padlock to secure the gate

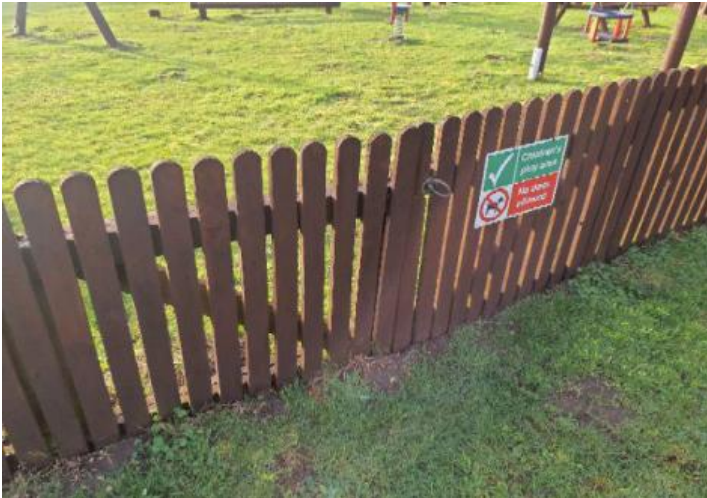
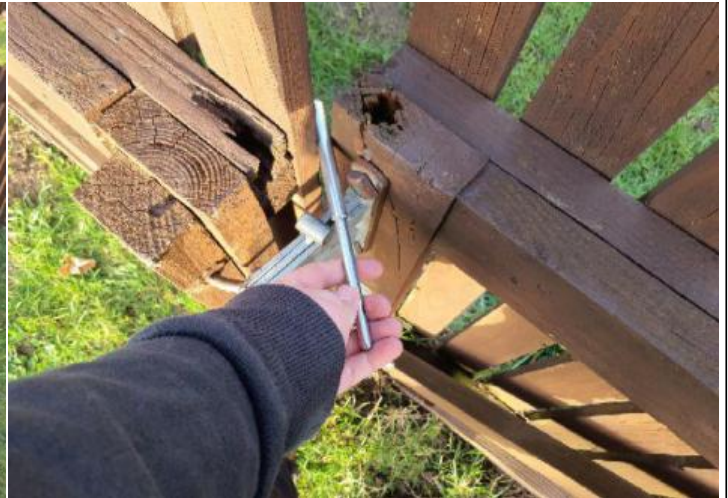
**Item:** Gates - Gate - Combination  
**Manufacturer:** Not Identified

**Finding:** There are openings that are less than 12mm that could trap or crush fingers

**Action:** Provide a 12mm gap throughout full range of motion at both sides of gate

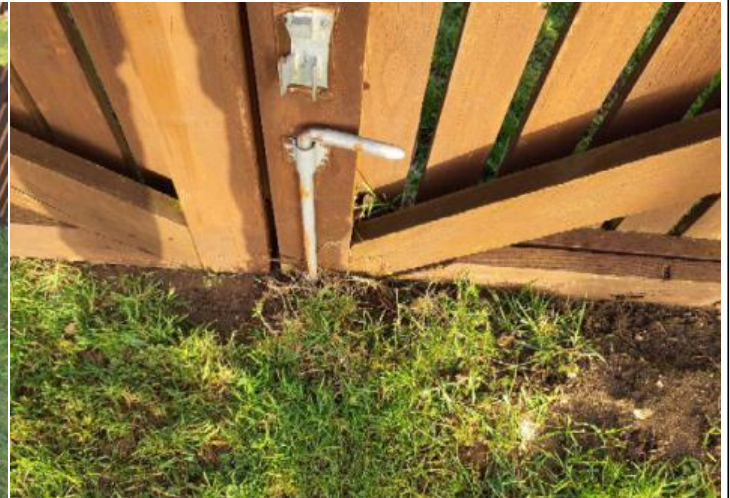
**Item:** Gates - Gate - Combination  
**Manufacturer:** Not Identified

**Finding:** The gate has no drop bolt sleeves and/or drop bolts fitted

**Action:** Provide drop bolt sleeves and/or drop bolts

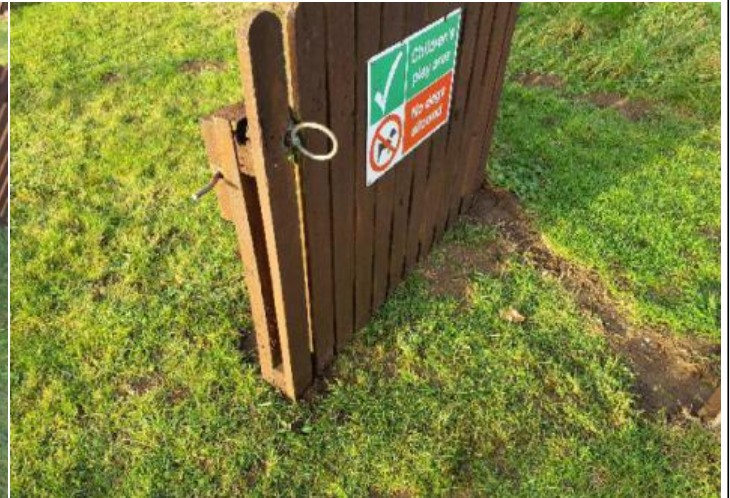
**Item:** Gates - Gate - Combination  
**Manufacturer:** Not Identified

**Finding:** The gate is snagging on the surrounding surface preventing it from closing correctly

**Action:** Carry out remedial works to ensure the gate closes correctly

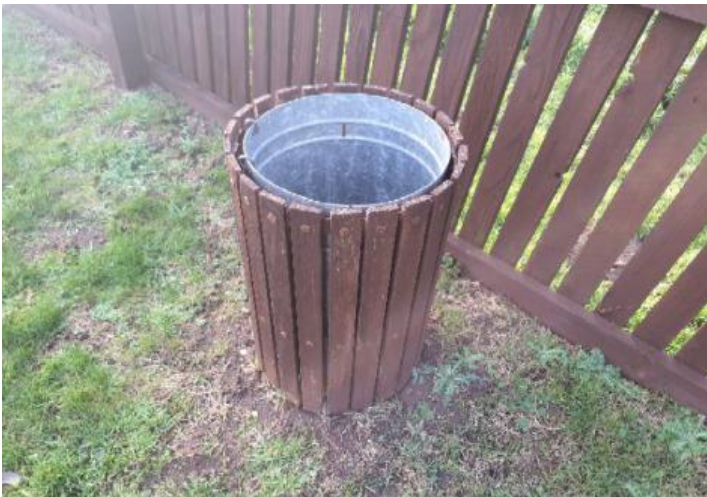
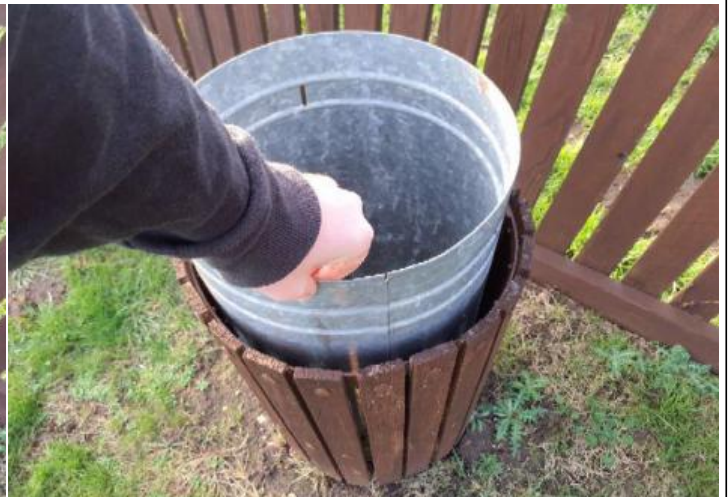
**Item:** Ancillary Items - Litter Bin  
**Manufacturer:** Not Identified

**Finding:** The liner of the litter bin is not secured and can be easily removed

**Action:** Ensure the liner is secured

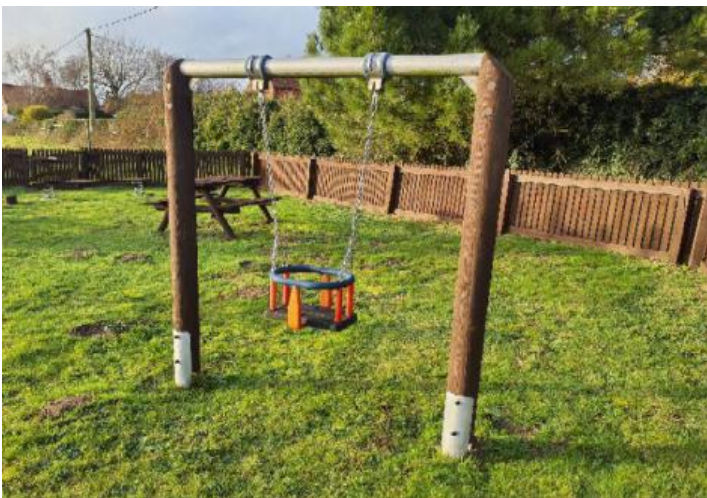
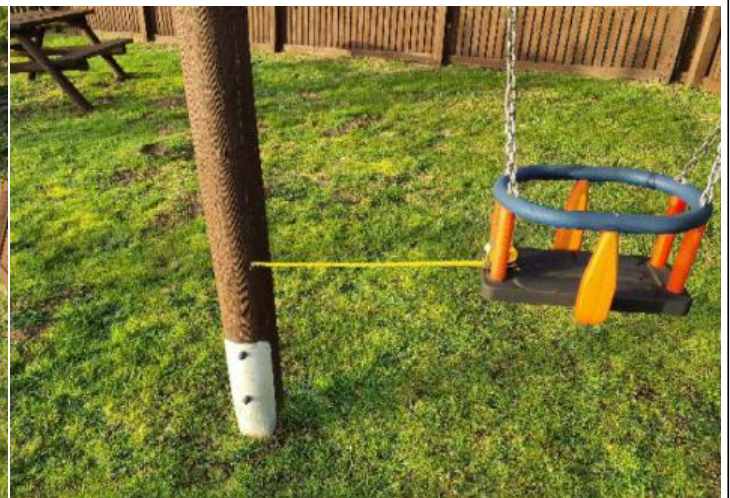
**Item:** Swings - 1 Bay 1 Seat (Cradle) - Type 1  
**Manufacturer:** Playdale Playgrounds Ltd

**Finding:** The seat/s is / are too close to the frame as defined in BS EN 1176 Part 2

**Action:** Monitor - No action given the risk assessment

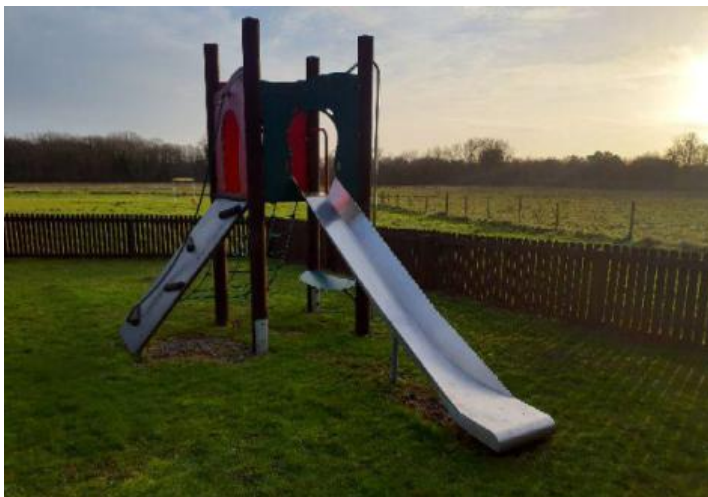
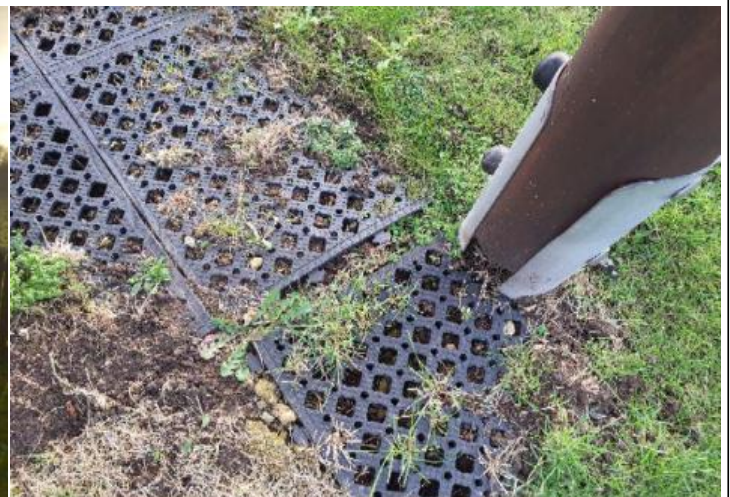
**Item:** Activity Equipment - Multi Play (Junior)  
**Manufacturer:** Playdale Playgrounds Ltd

**Finding:** There are gaps opening between the grass mat tiles

**Action:** Provide additional ties or secure / reinstate surface

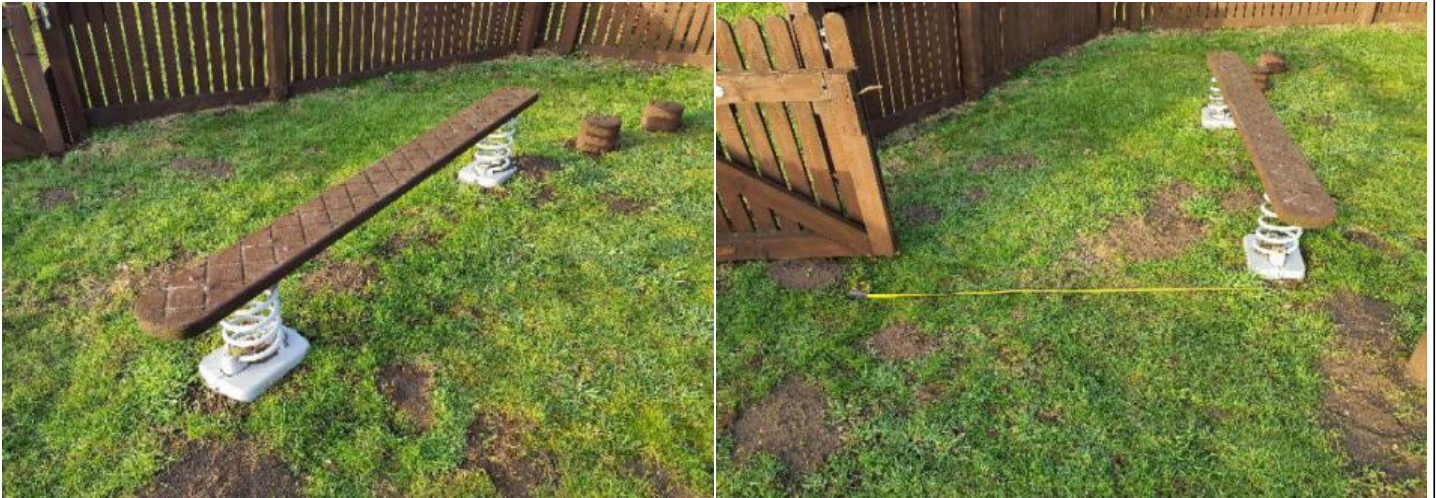
**Item:** Activity Equipment - Spring Balance Beam  
**Manufacturer:** Playdale Playgrounds Ltd  
**Risk Level:** L - Low Risk  
**Surface:** Grass

**Finding:** The gate when opened forms a projecting obstacle / hard object within the falling space of the equipment, in contravention of the requirements of BS EN 1176 Part 1  
**Action:** Monitor - No action given the risk assessment
